U.S. Chemical Safety and Hazard Investigation Board

## AL Solutions, Inc., New Cumberland, WV Metal Dust Explosion and Fire

December 9, 2010

No. 2011-3-I-WV

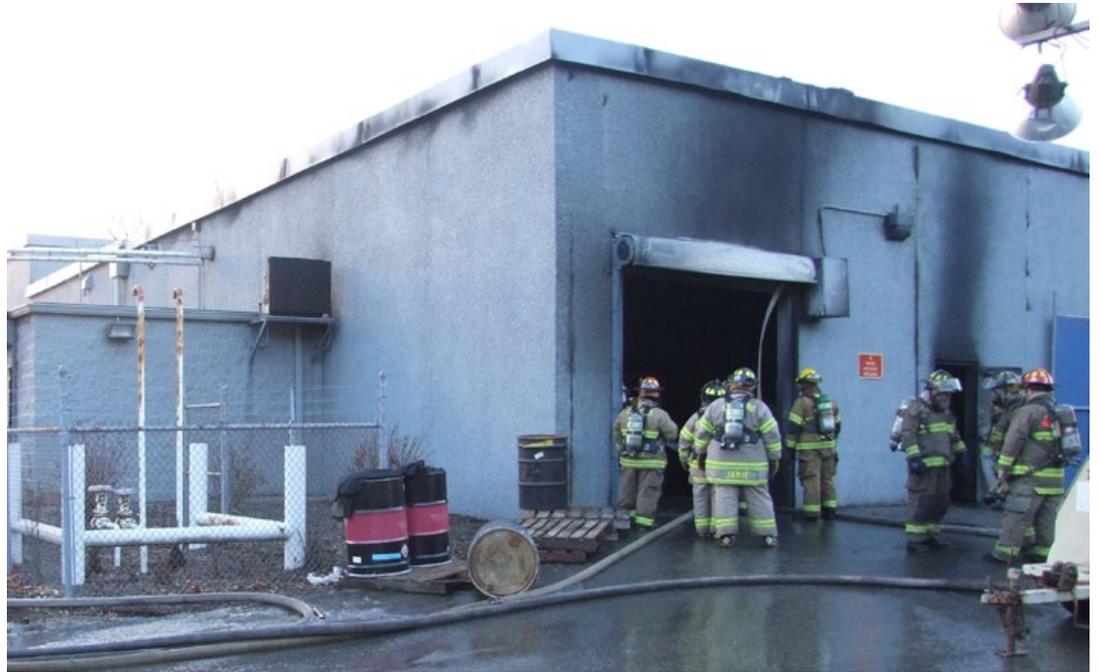
FIGURE 5

Production Building Exterior, with Firefighters on Scene (photograph courtesy of the New Cumberland Police Department).

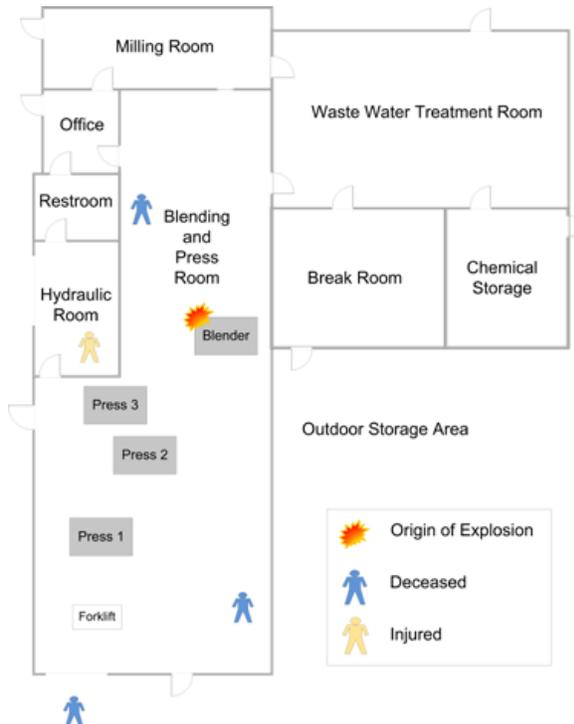
FIGURE 6

Main Production Building Layout, Likely Initiation Point of the Incident, and Worker Injury and Fatality Sites

The two operators in the blending and press room died at the scene, and the zirconium press operator died three days following the incident from severe burn injuries. The explosion and subsequent fire caused minor blast damage to doors, walls, and interior windows as well as more substantial thermal damage throughout the production area (illustrated in Figure 7). The explosion caused thermal damage to the wall and overhead ceiling area adjacent to the blender (shown in Figure 8). Equipment damage included a lift truck, the blender, and the press feed conveyor. The explosion propelled papers, desks, and lockers from the office into the parking lot outside of the production building.

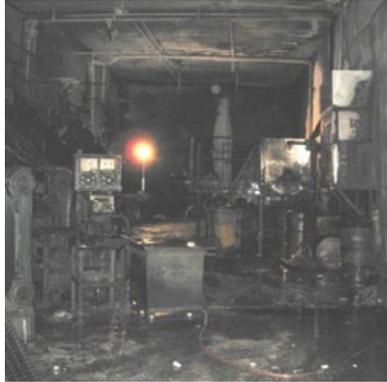
FIGURE 7 (LEFT)

North End of Blending  
and Press Room

On the basis of production operations at the time of the incident, the blender likely contained a substantial quantity of zirconium. Indications of burned residue and char on the ceiling above the blender (shown in Figures 7 and 8) and the presence of burning deposits on the wall behind the blender suggest that the burning zirconium particulates lofted from the blender after the initial explosion, engulfing the room in fire. After the incident, the blender lid, intended to be closed during production, was found left in the open position. The scraping of the blender blades against the sidewalls of the blender likely ignited the zirconium powder early in the incident sequence. The cloud of combustible zirconium resulted in a deflagration.<sup>15</sup> Hot gases expanded, producing the “woof” or “wind” observed by two witnesses. The burning zirconium dust cloud also ignited open drums and tubs of titanium and zirconium at several locations in the production building, propagating the fire.

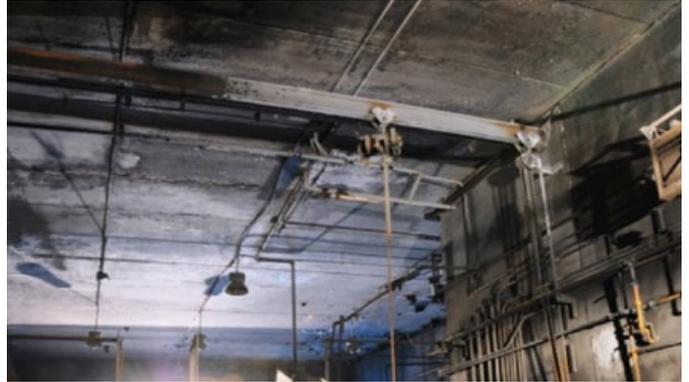
FIGURE 8 (RIGHT)

Ceiling in Blending and  
Press Room

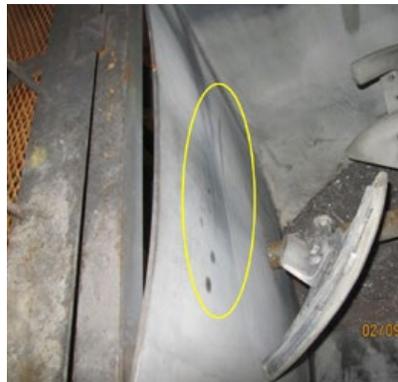
**FIGURE 10 (LEFT)**

The pre-explosion sound of metal failure or popping reported by AL Solutions employees likely originated in the blender, which showed evidence of the most substantial metal deformation after the incident. Both endwalls were deformed inward and had visual indications of the blade scraping or scoring on the wall (Figure 10). Residual burned zirconium was detected in the blender beneath the shaft. Severe burn damage was also seen in the press on the other side of the production room (shown in Figure 11) and there

Zirconium Blender Wall Deformation and Scoring (circled)

blender and scoring the housing. To address these problems, maintenance personnel adjusted the blender blades to increase clearance from the blender wall, but this action did not permanently address the issue with the metal-to-metal contact. When the problem returned, maintenance personnel decided to replace parts of the blender in an effort to resolve the issue. While the operators were disassembling the blender, they discovered a large groove cut in the shaft and an 8-inch to 12-inch crack in the sidewall of the blender, most likely caused by the paddle blades scraping the sidewall. The maintenance worker welded this crack, and operators continued to use the blender.

On the morning of the incident, an operator requested that maintenance replace a worn paddle in the blender. A maintenance employee retrieved a paddle from an old blender and attached it to the blender in the production building about two hours before the incident. All of the maintenance performed on the blender only temporarily addressed the problems caused by the metal-to-metal contact, such as the scoring on the sidewall and worn paddles. AL Solutions did not repair or replace the blender to avoid exposing combustible metal dusts to sparks or heat produced by the mechanical impact from the paddles.

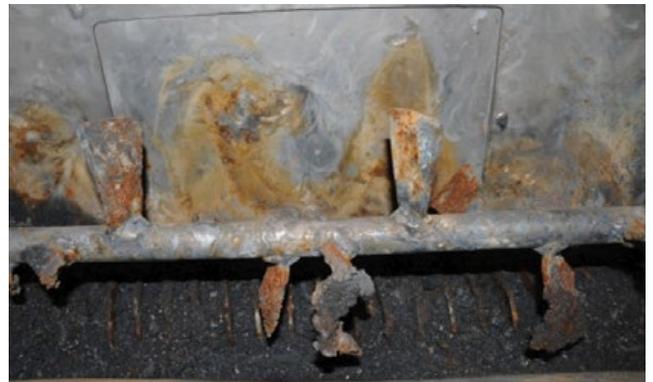
**FIGURE 11 (RIGHT)**

Press Blade Damage

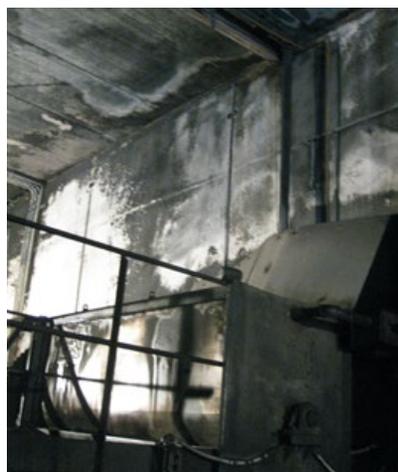
**FIGURE 12**

Blender and the Adjacent Wall and Ceiling

Investigators examined the production building wall and ceiling adjacent to the blender and found visual evidence of a burning dust cloud projected upward toward the ceiling (displayed in Figure 12).

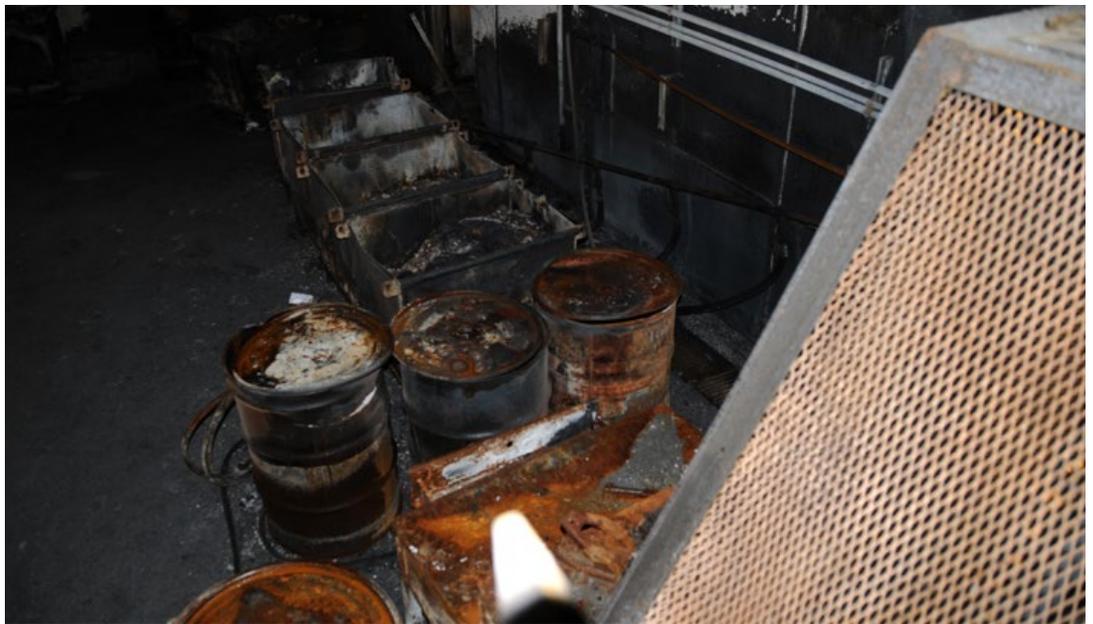
**FIGURE 15**

Drums of Titanium and Zirconium Particulates near Blender

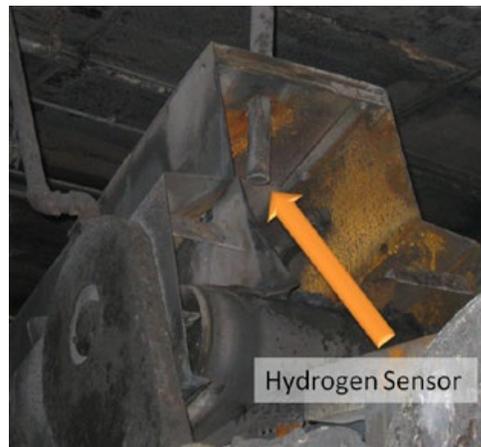
FIGURE 16

Hydrogen Sensing Port at the Top of the Press 2 and 3 Conveyor Belt (post incident)
