## Accident - Bridge collapse in North Carolina

On April 14, 2021, at approximately 5 p.m., the last span of the Herbert C. Bonner Bridge (Bonner Bridge) under demolition collapsed in Dare County, North Carolina. An employee of PCL Civil Constructors, Inc. (PCL), engaged in the steel cutting, was killed. The collapsed span was the navigation span of the Bonner Bridge measuring 180 feet long, 24 feet wide, and approximately 60 feet above sea level, with a total weight of 980 kips.<sup>1</sup>

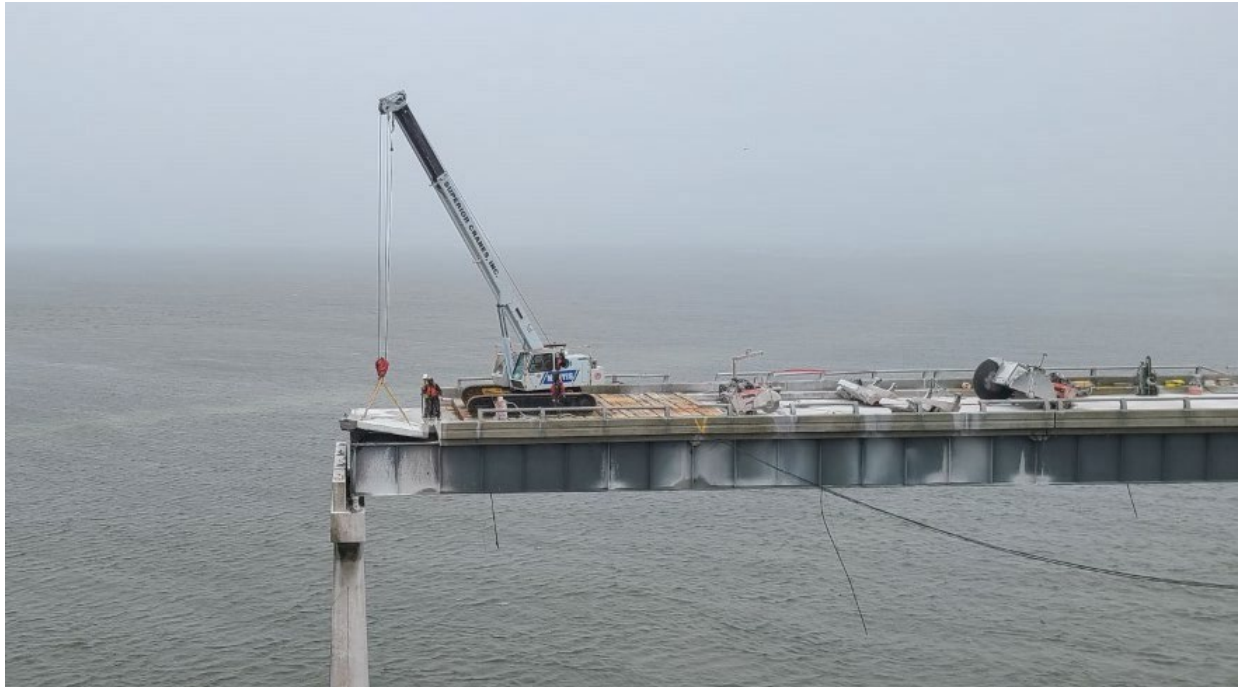
February 15, 2021, PCL began saw cutting and removing concrete panels in Span 144 (see Figure 12, a photograph taken by NCDOT on 2/15/2021). PCL did not follow KCI's demolition plan from the initial of the demolition in that:

1. PCL removed the center bay of the bridge deck immediately after removing the deck overhang and parapet sections in the same area. In contrast, KCI's demolition plan specified that the center bay of the bridge deck in a span could only be removed after all deck overhang and parapet sections within that span were removed.
2. PCL placed the removed sections of concrete on the deck behind the crane until they were placed on the barge (see Figures 13 and 14)

Figure 12 – Demolition of Span 144  
(photographed on 2/15/2021 by NCDOT)

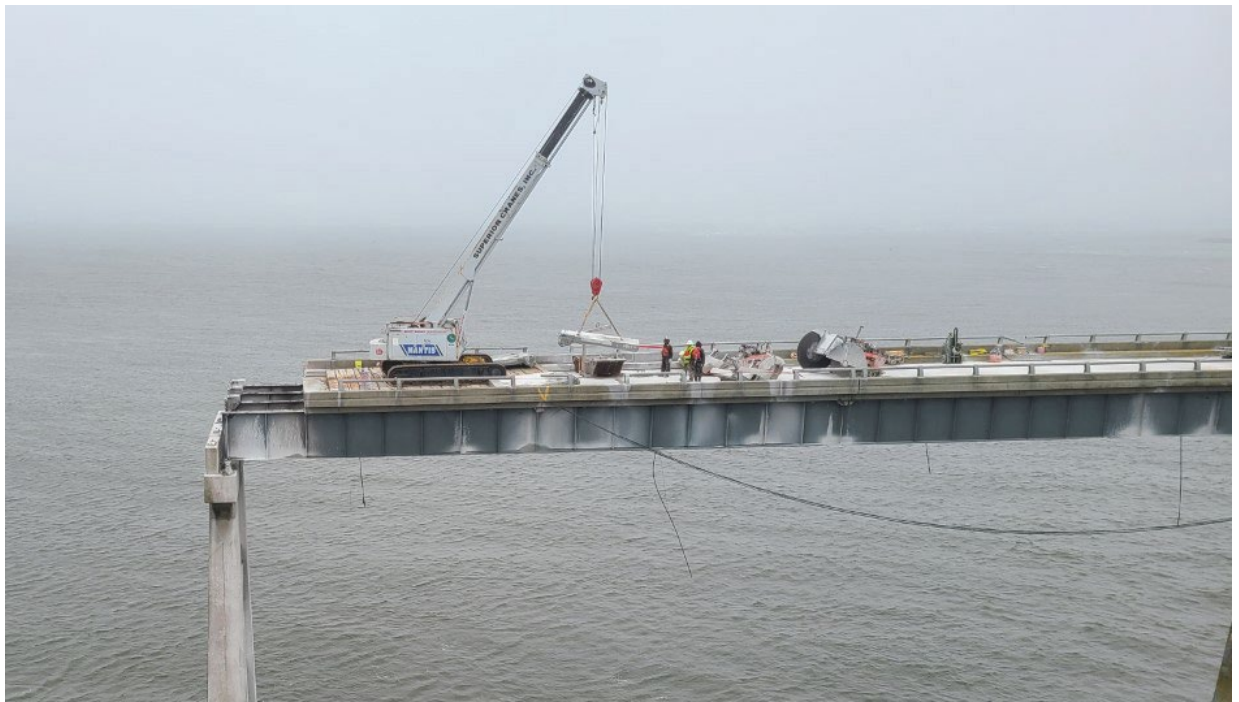
Figure 13 – Demolition of Span 144  
(photographed on 2/15/2021 by NCDOT)

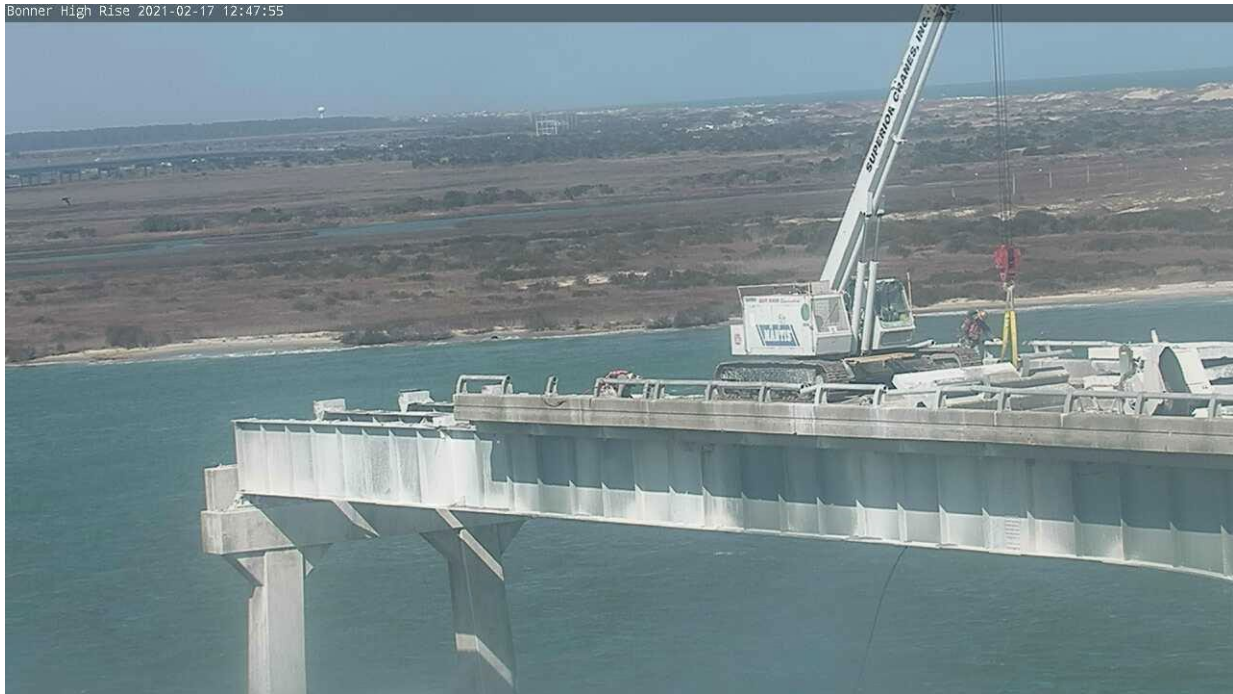
Figure 14 – Demolition of Span 144  
(photographed on 2/17/2021 by NCDOT)

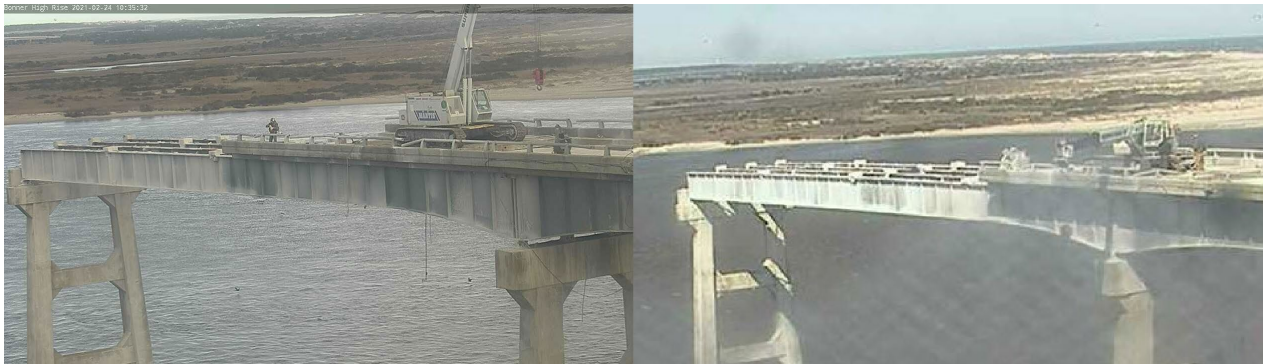
Figure 15 – Demolition of Span 144  
(photographed by NCDOT)

After examining the demolition progress photographs taken by NCDOT on February 24 and 25, 2021 (see Figure 15), OSHA found that PCL did not stop stacking concrete debris on the deck while they were coordinating the plan changes with KCI.

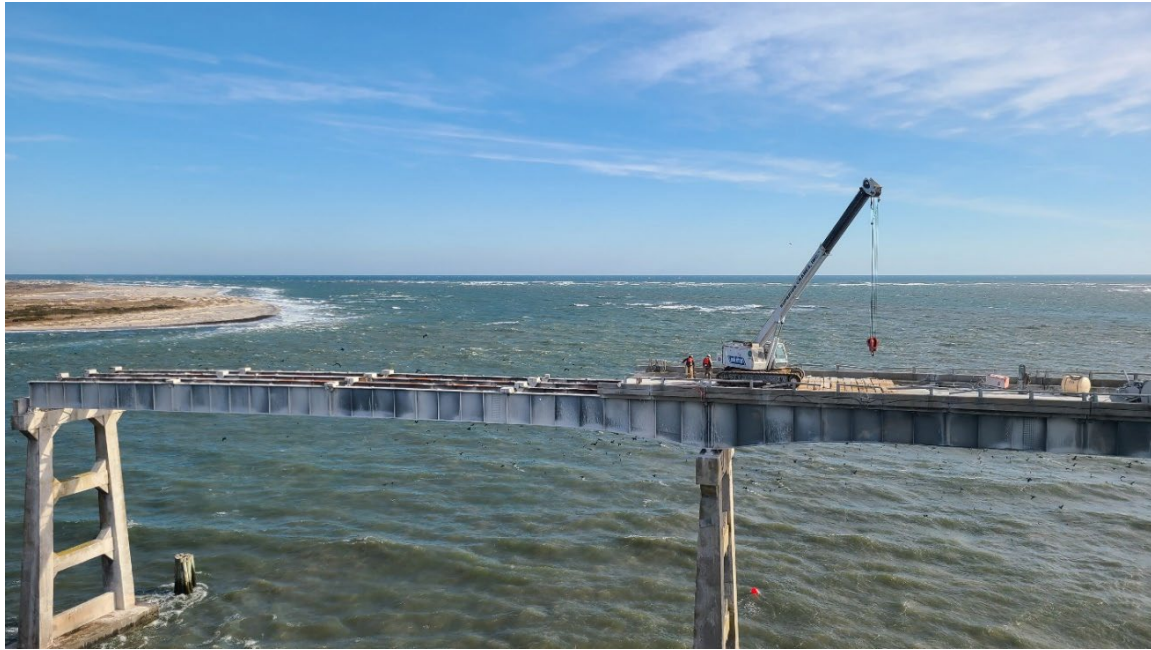
March 2, 2021, PCL began cutting the concrete deck in Span 145 (see Figure 16). PCL stockpiled deck overhang and parapet segments on Span 145 (see Figures 17 and 18). PCL did not follow KCI’s demolition plan, nor the supplemental memorandum dated February 25, 2021.

Figure 16 – Demolition of Spans 144 and 145  
(photographed on 3/2/2021 by NCDOT)

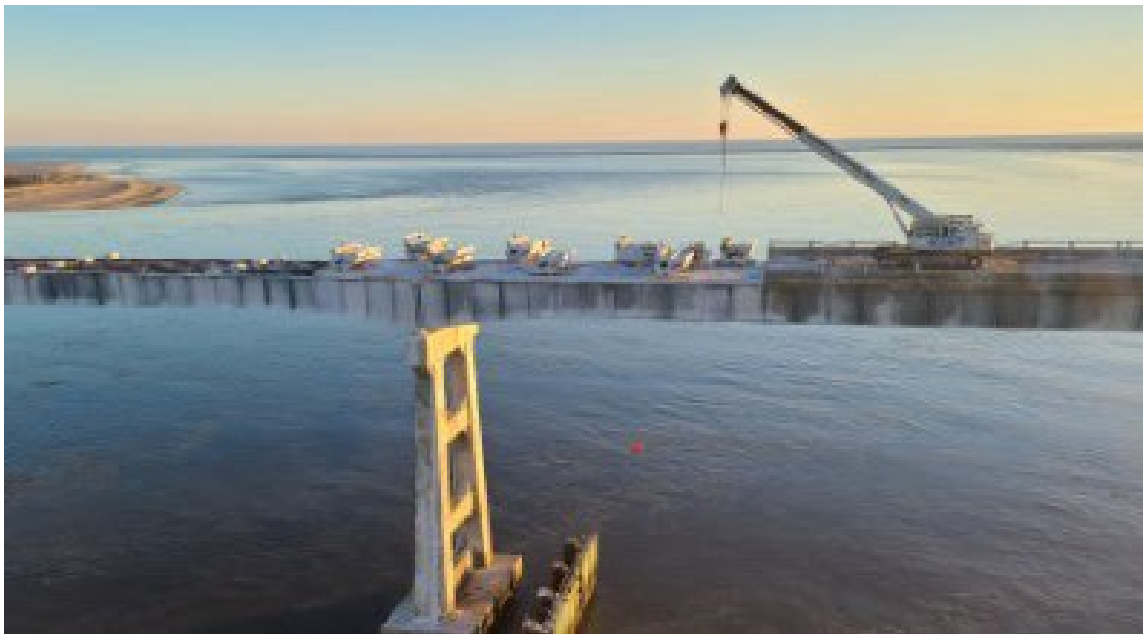
Figure 17 – Demolition of Span 145  
(photographed on 3/4/2021 by NCDOT)

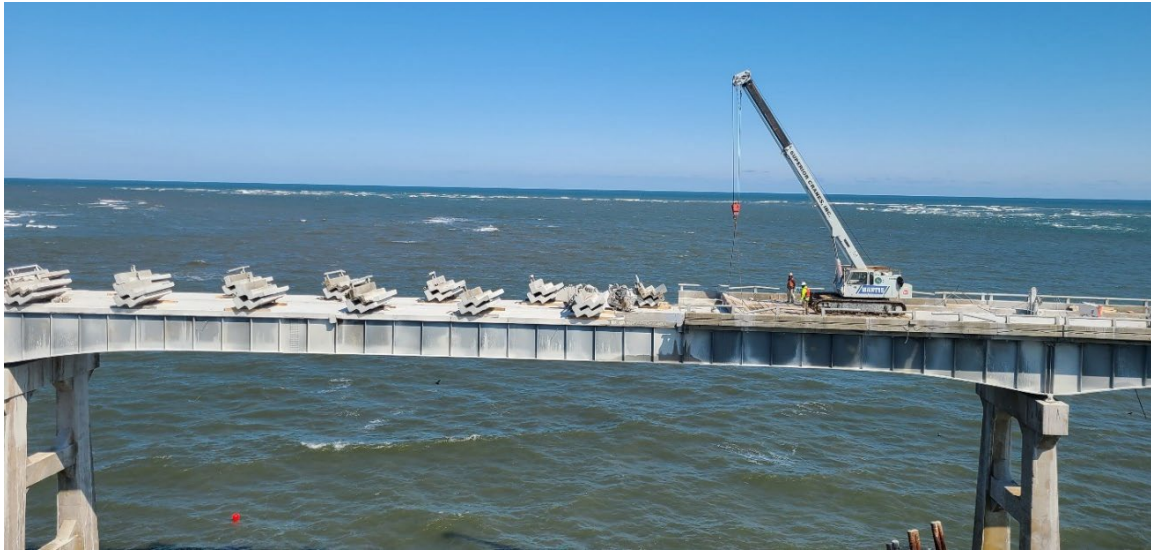
Figure 18 – Demolition of Span 145  
(photographed on 3/5/2021 by NCDOT)

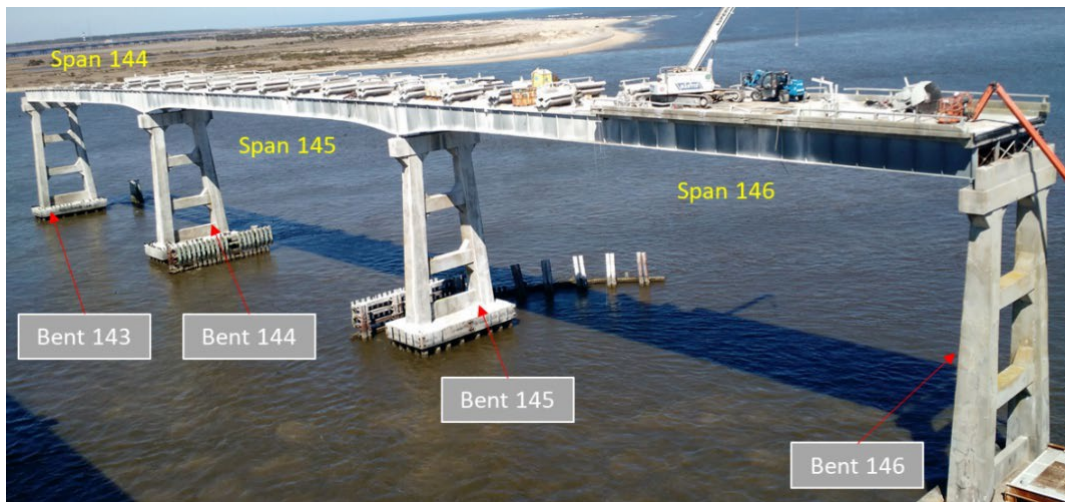
March 10, 2021, PCL developed a plan for stacking deck overhang and parapet segments on Span 146 (see Figure 19). Figure 20 illustrates that PCL placed all overhang and parapet segments on Spans 145 and 146.

Figure 20 – Three steel girder spans under demolition – Looking north (photographed on 3/11/2021 by NCDOT)

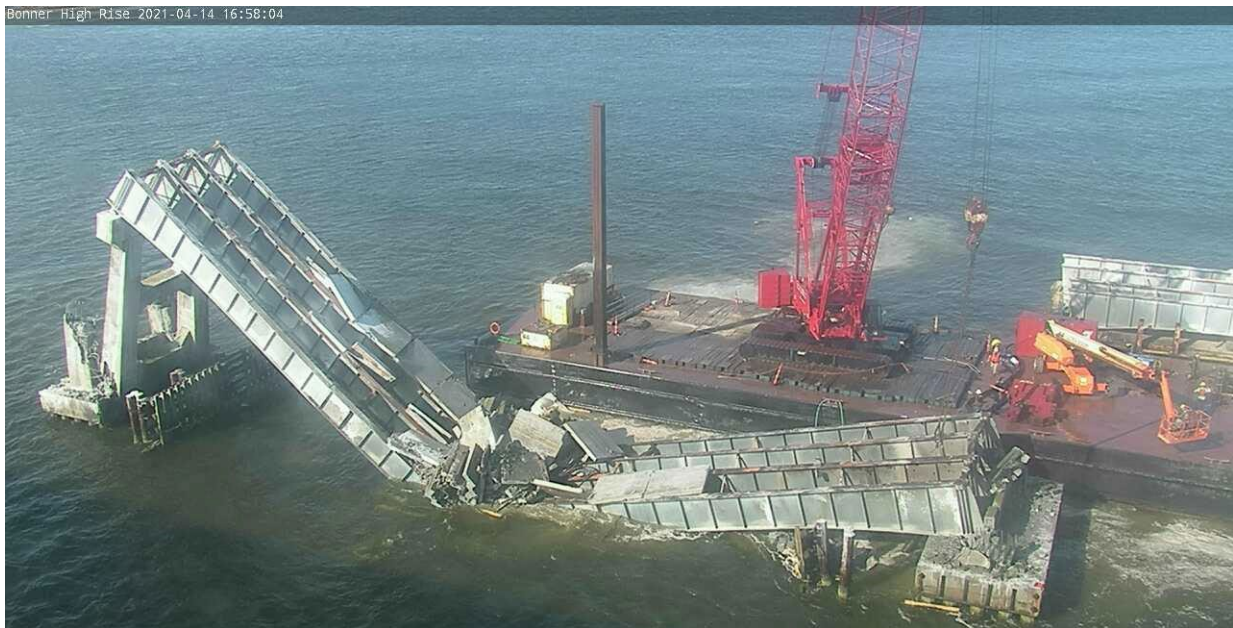
April 14, 2021, PCL cut the four steel girders in Spans 145 and 146 at Bent 145 and removed the four girder segments in Span 146 utilizing two marine cranes (see Figure 25). Shortly after Span 146 was removed, Span 145 collapsed (see Figure 26).

Figure 26 – Collapsed steel girders in Span 145  
(photographed on 4/14/2021 by NCDOT)

Figure 26 shows the condition and failure pattern of the girders in Span 145 after the collapse. The girders formed a “V” shape at failure, with concrete deck and parapet segments on top at the mid-span region, indicating a significant amount of bending took place in the middle of the span. Bent 145 crumbled completely, leaving the south ends of the girders resting on the footing (see Figure 27). The two columns of Bent 144 fractured at the construction joint approximately 18’ above the waterline and dropped onto the footing (see Figure 28). The north ends of the girders remained attached to the cap of Bent 144 after the collapse occurred. All girder bearings were still attached to the bottom flanges of the four girders after the incident (see Figure 29).

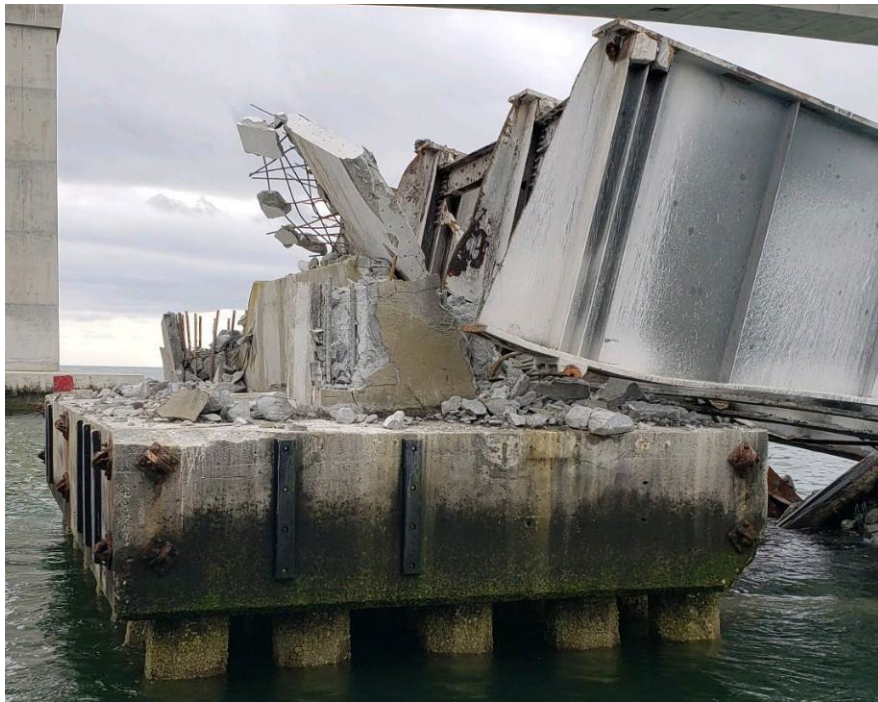
Figure 27 – Collapsed Bent 145

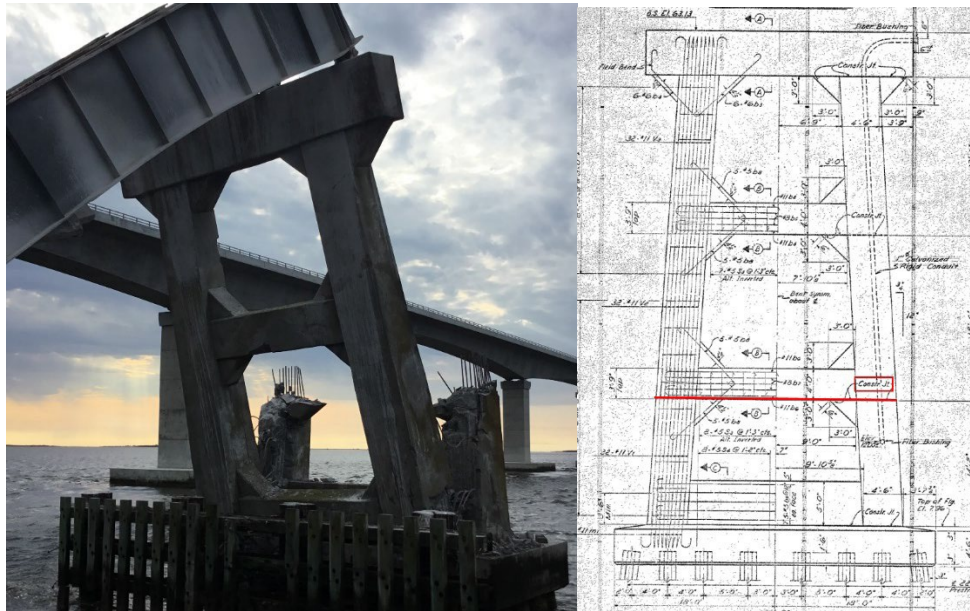
Figure 28 – Collapsed Bent 144

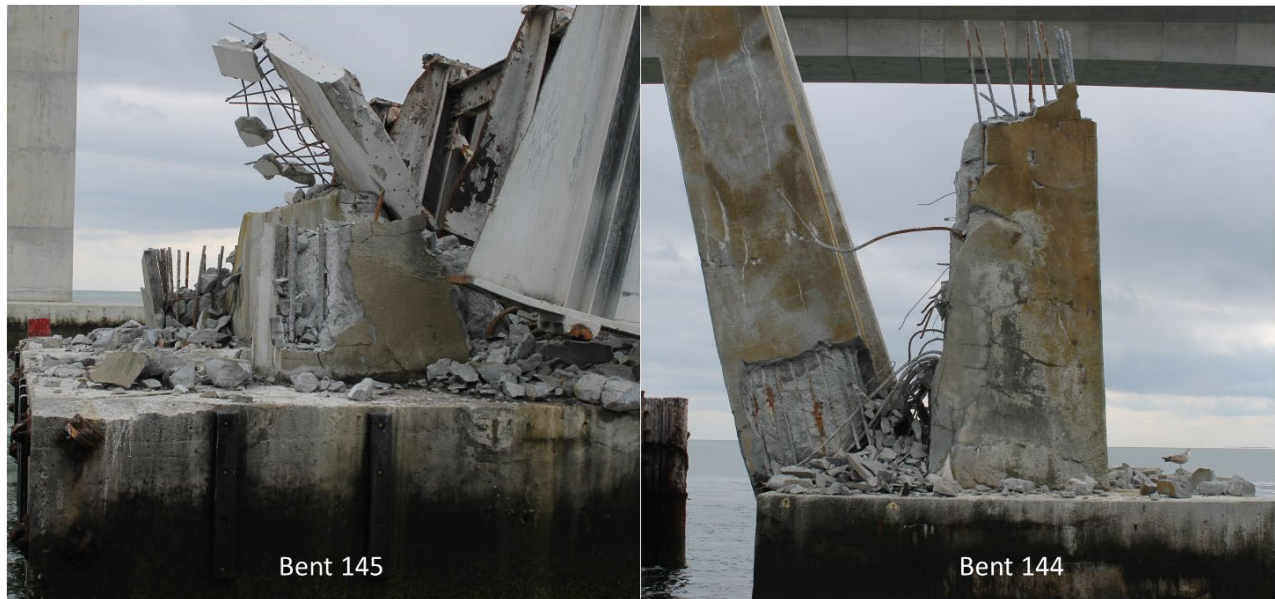
OSHA observed during its field investigations severe reinforcement corrosion and corresponding concrete deterioration, including scaling, delamination, spalling and cracking of the concrete in

the reinforced concrete columns of Bents 144 and 145 (see Figure 30). Photographs of Bents 144 and 145 taken before the demolition revealed signs of steel reinforcement corrosion and concrete spalling, i.e., concrete surface cracking, rust staining, and concrete plating (see Figure 31). The concrete deterioration is mainly due to the aggressive exposure conditions for these concrete structures in the marine environment. The structural integrity of the bridge bents might have been compromised before the incident.

Figure 30 – Collapsed Bent 144/145

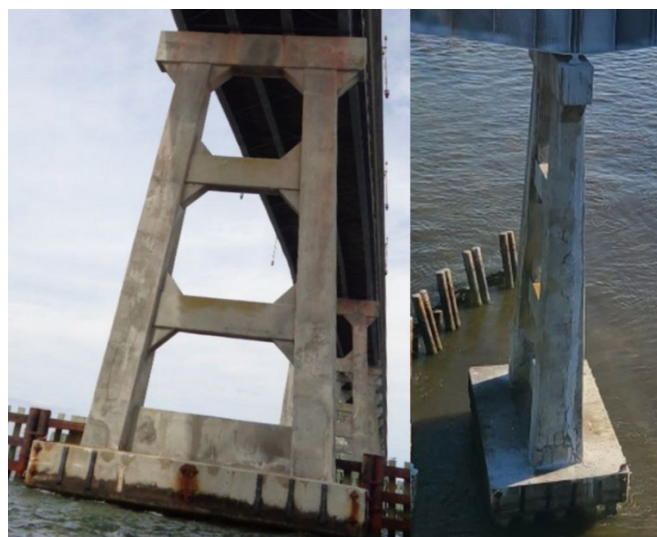
Figure 31 – Concrete deterioration

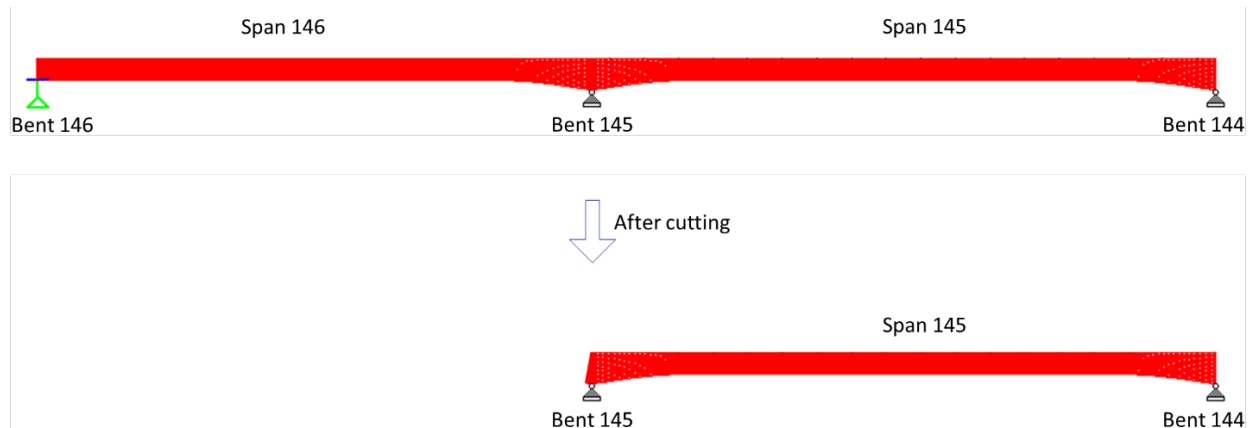
On the day of the incident, before PCL cut the four plate girders in Spans 145 and 146 at Bent 145, these girders were 2-span continuous girders, extending over three supports at Bents 144 to 146 (see Figure 36). Once PCL cut the four girders at Bent 145, the girders remaining in Span 145 became simply supported girders with a much less load-carrying capacity than the 2-span continuous girders before cutting. Our FE analyses confirmed that the maximum Von Mises stress in the girders in Span 145 due to the imposed loads exceeded the yield stress of the A-373 steel, indicating that yielding of steel at some point in these girders occurred when the incident happened.

Figure 36 – Plate girders before and after cutting

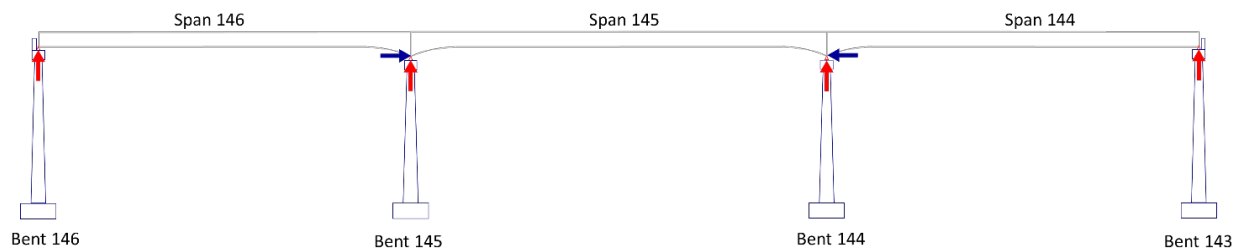
Because the supports at both ends of the girders in Span 145 were pin supports, which allowed rotation but prohibited vertical and horizontal displacement, the bottom flanges of the girders were prohibited from extending when subject to tension caused by positive moment.<sup>13</sup> This restraint of the bottom flange extension resulted in substantial horizontal reactions at the pin supports on top of the two interior bents (blue arrows in Figure 37). As a result, the columns of Bents 144 and 145 were subjected to axial and transverse loads and bending moment.

Figure 37 – Support reactions at Bent 144/145<sup>14</sup>

OSHA's analysis indicated that the weight of the steel and concrete in Span 145 overloaded Bents 144 and 145 at the time of the incident.
