Accident- Tank Farm explosion and fire in Deer Park, Texas

The CSB determined that the cause of the incident was the release of flammable butane-enriched naphtha vapor from the failed Tank 80-8 circulation pump, which accumulated in the area and ignited, resulting in a fire.

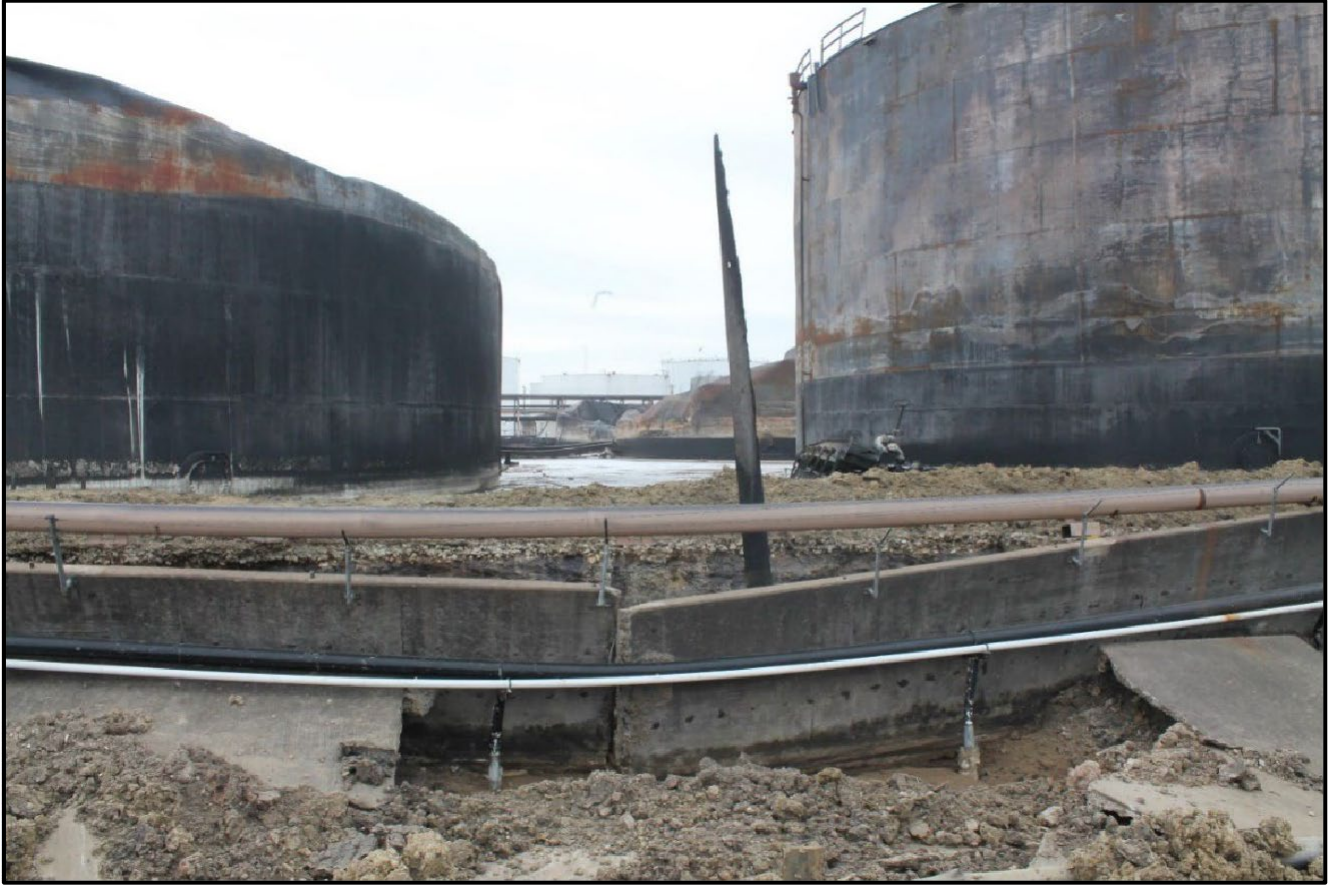
(Figure 16). The release also resulted in the potential for elevated levels of volatile organic compounds (VOCs)^a in the immediate industrial area. As a result, ITC notified its industrial neighbors and local state parks of the potential exposure and recommended that they shelter in place. The breach in the containment wall measured roughly 10 feet in width (Figure 17).

Figure 17. Close-up view of the First & Second 80's tank farm containment wall breach that occurred on Friday, March 22, 2019. (Credit: HCFMO).

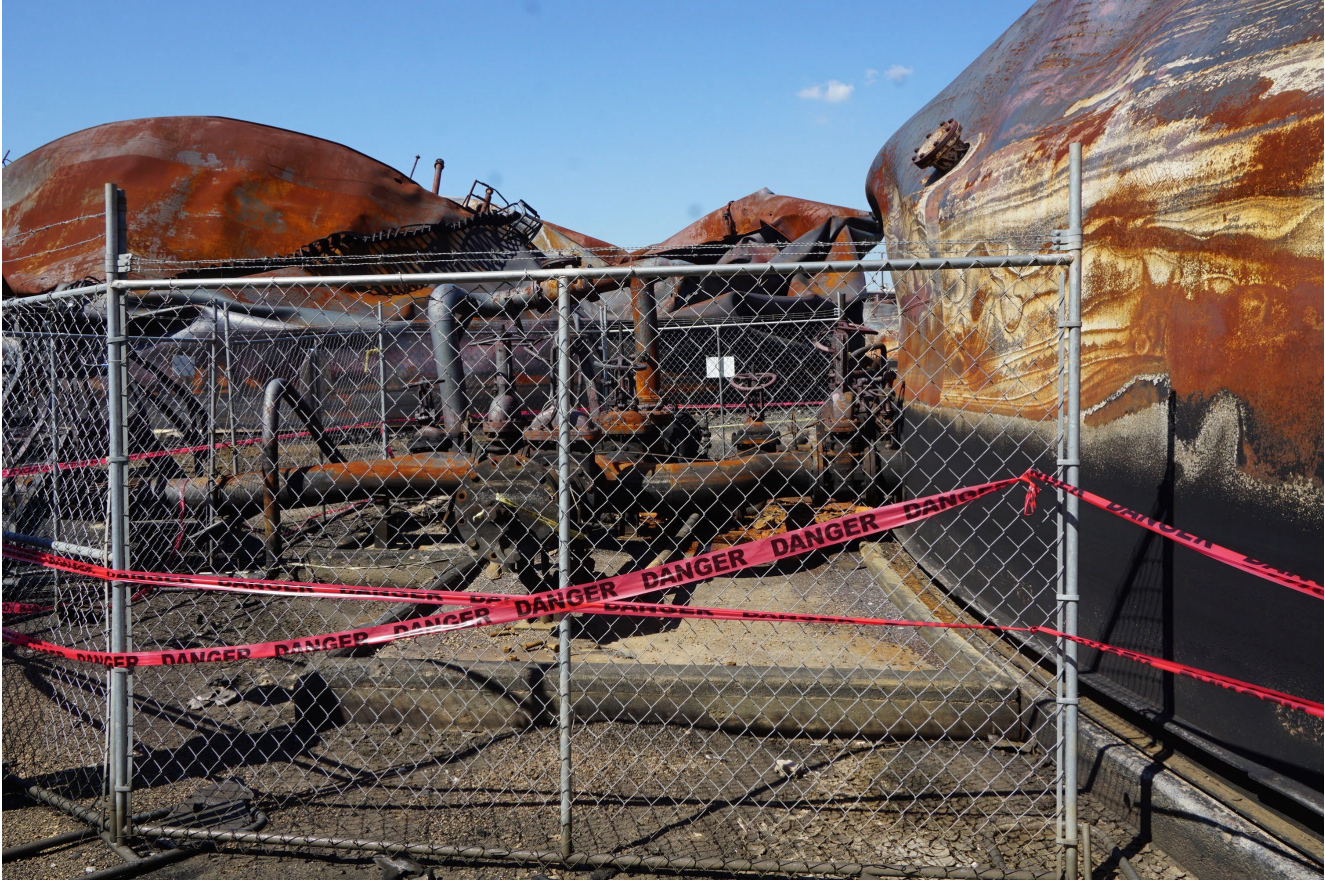
Figure 30. Small concrete containment area around the Tank 80-8 circulation pump. (Credit: CSB)

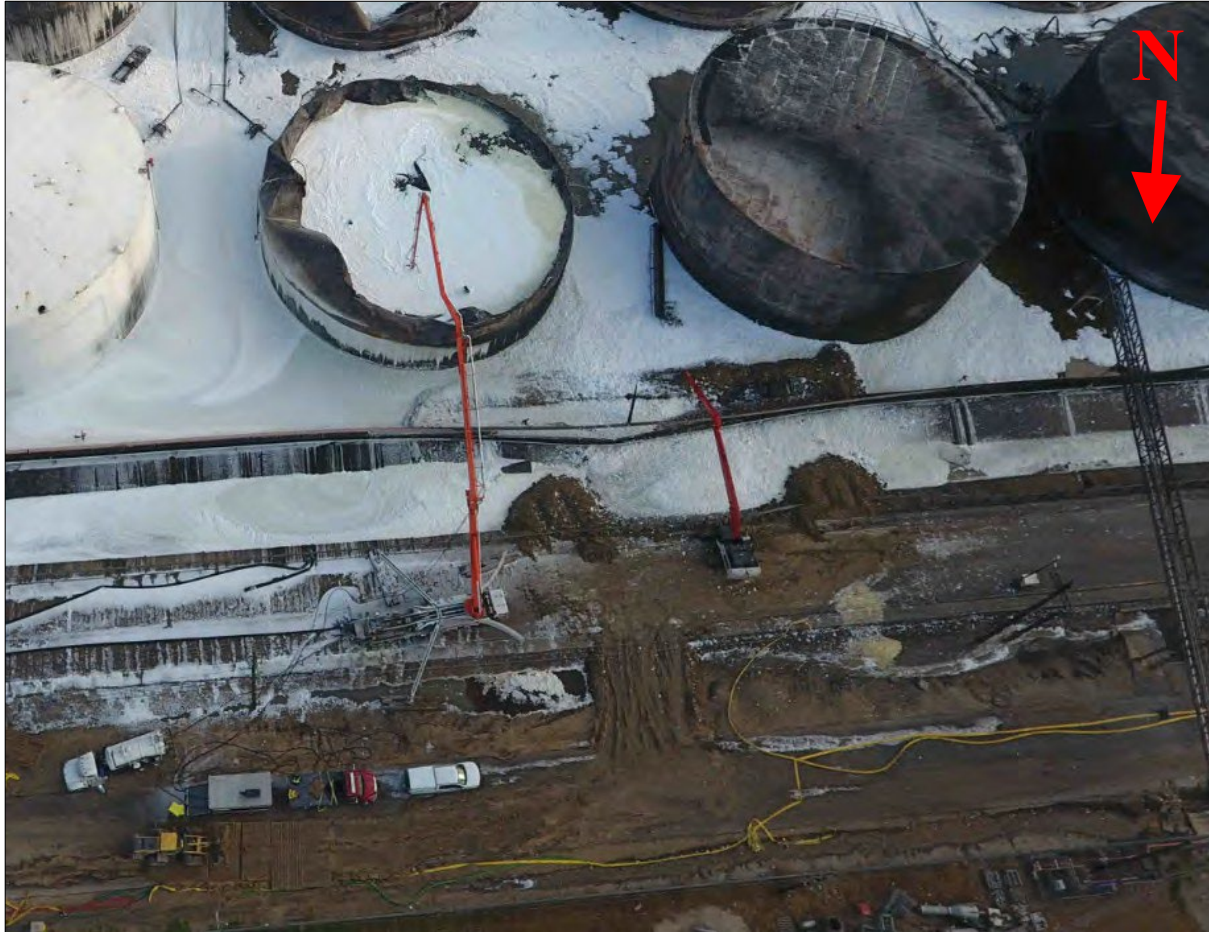
Photo 5: Responders constructing soil dike wall inside containment area to mitigate breach¹³

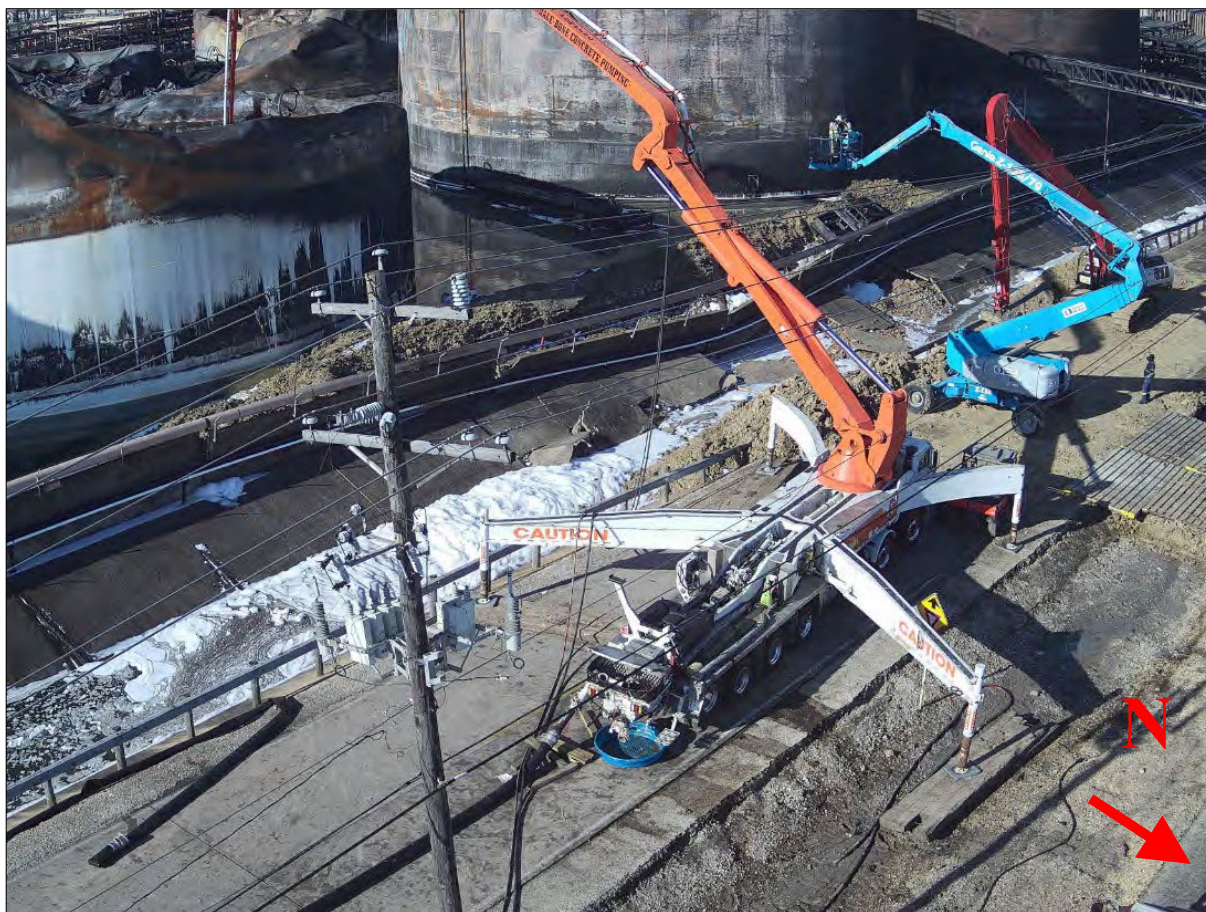
Photo 8: View of containment wall failure, after temporary dike wall was constructed¹⁶

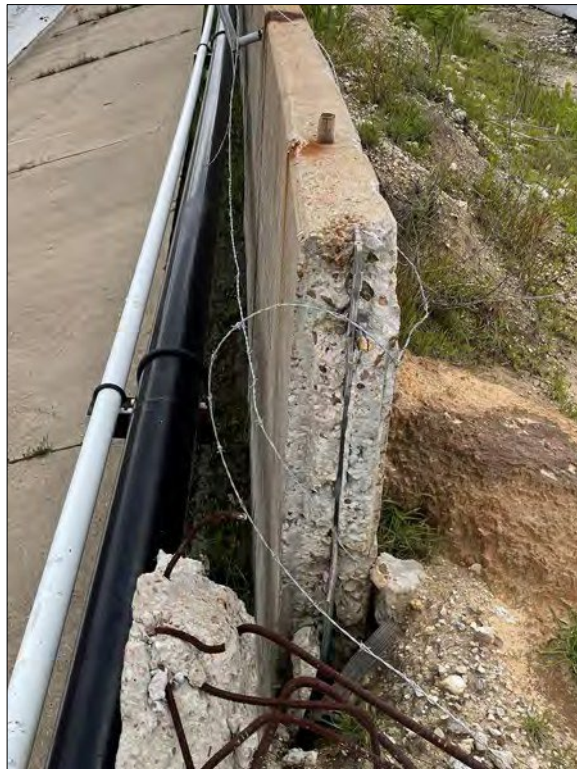
Photo 14: Torn waterstop and displaced wall. Upper section of wall that was displaced has been partially demolished during remediation efforts.

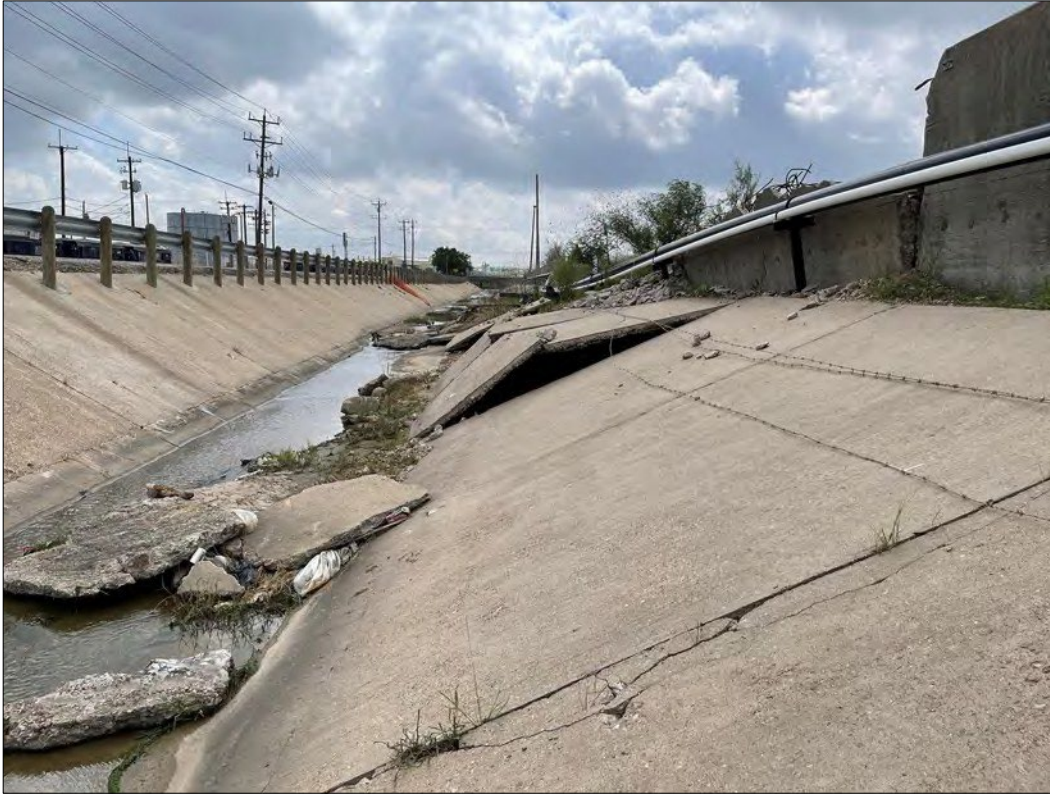
Photo 16: Damaged Section of Drainage Ditch, looking east

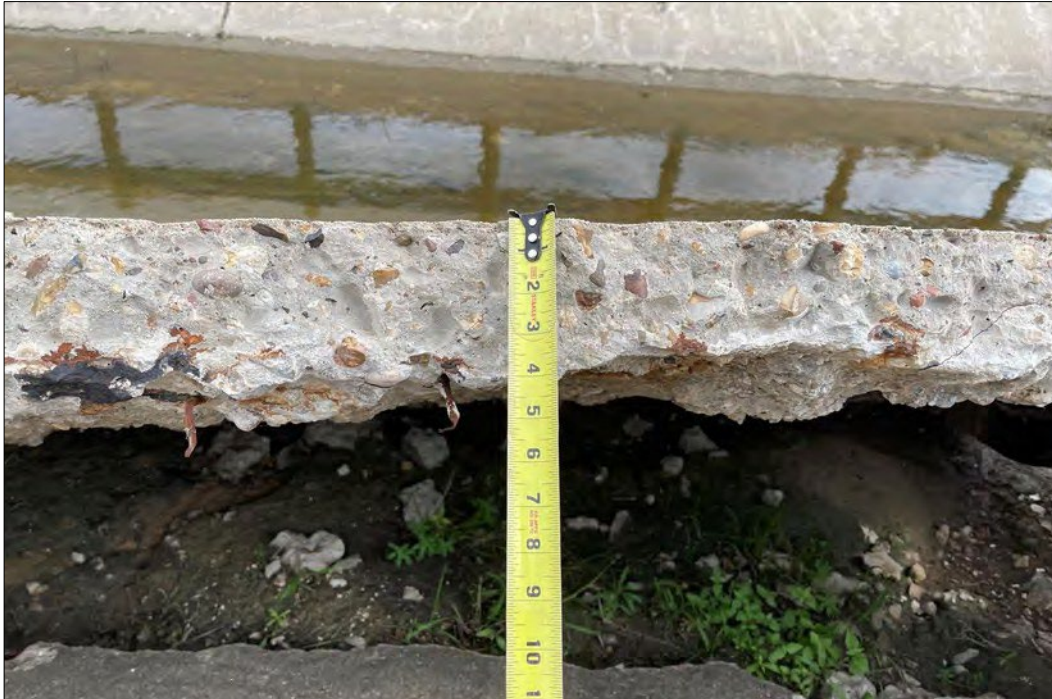
Photo 17: Displaced section of concrete slab that formed sloped sidewall of ditch
