## **Accident- Dollar General store roof collapse in Florida**

Investigation of the November 8, 2021, Partial Collapse of Wood Roof Trusses during Construction of Dollar General Store, Orange City, Florida

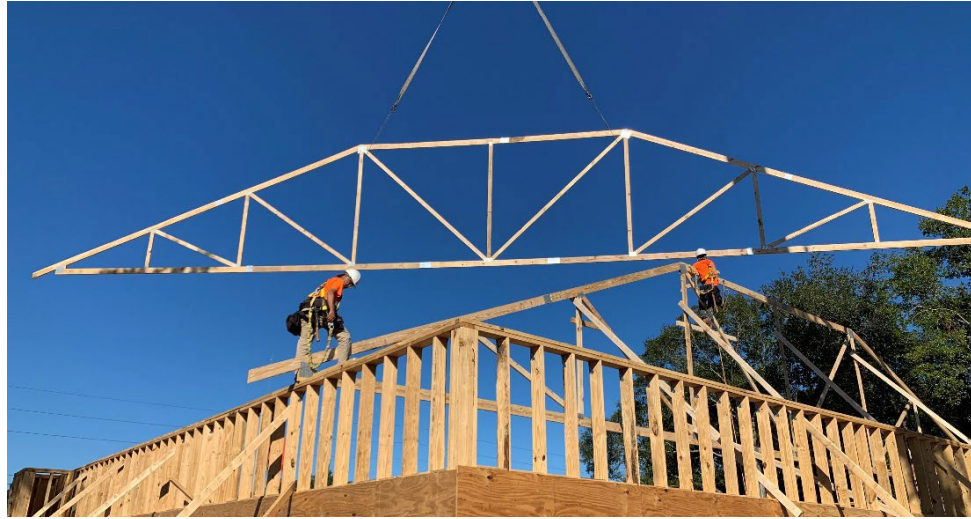
Figure 7 – Truss erection – looking northwest  
(Courtesy of WW Build)

All trusses were delivered to the site on October 28, 2021. The setting of piggyback base trusses began on November 3, 2021. The first truss was erected the same day (November 3), approximately 9'-4" from the east wall (see Figure 7). The first truss was laterally braced at six locations using 2"x4" braces from vertical posts to the east wall (see Figure 8). On November 4, 2021, the last piggyback base truss near the west wall was erected and braced at multiple locations to the west wall (see Figure 9).

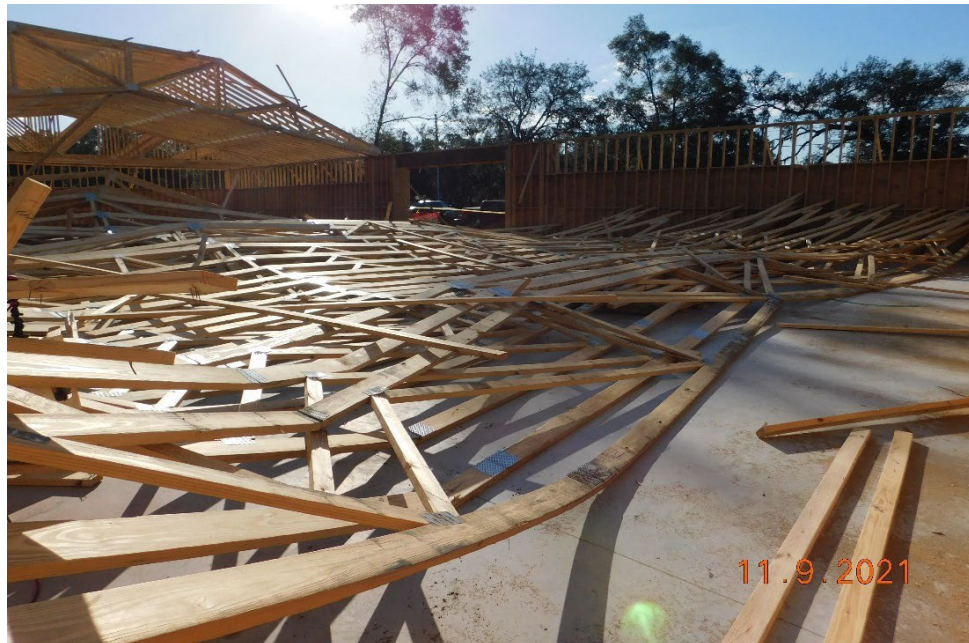
Figure 11 – Collapsed roof trusses – looking southeast

Approximately 1:30 p.m., while the three Top Rank employees continued working on adding more bracings, trusses at the west side of the building started to fall toward the east (see Figure 11). Two Top Rank employees fell more than 12 feet onto the concrete floor and were injured. The Top Rank employee located on the ground cutting lumber was struck by fallen trusses and died instantly at the jobsite.

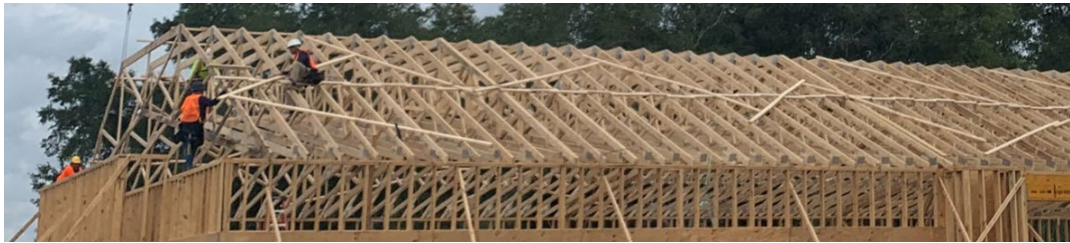
Figure 12 – Truss braces at the south side – looking north  
(Photo by WW Build)

Top Rank installed both diagonal and lateral braces (short lumber pieces) on the north and the south side of the trusses. Figure 12 shows the truss bracing installed on Nov. 4, 2021, after completion of piggyback base truss erection. Long diagonal and short member temporary lateral restraints installed on the north side of the trusses prior to the collapse were observed after the incident during OSHA’s field investigation (see Figure 13). Additionally, OSHA found that bottom chord and web member bracing were not installed prior to the collapse (see Figure 14).

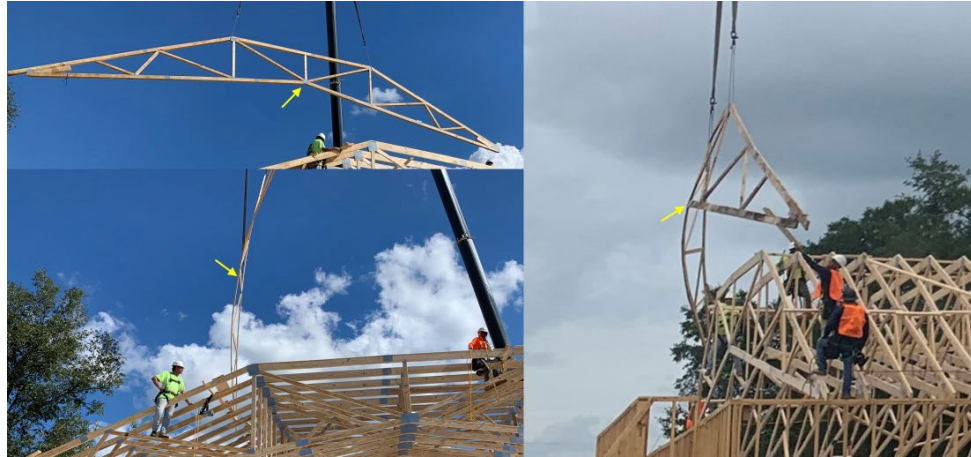
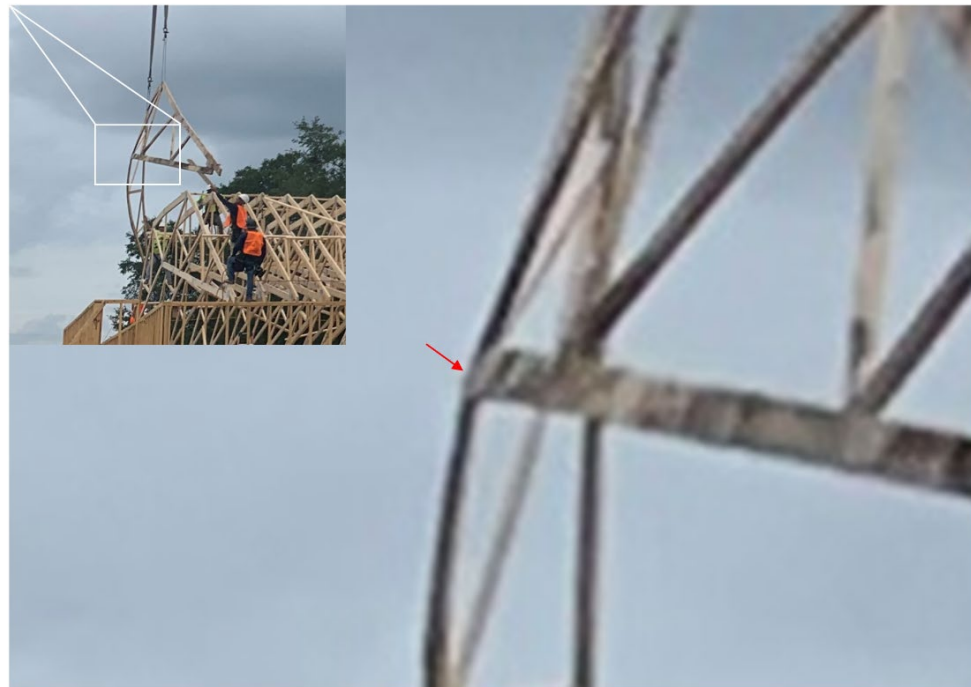
Figure 15 – Truss hoisting  
(Photo by WW Build)

After reviewing the construction progress photographs taken by WW Build, OSHA found that the wood trusses were not properly hoisted. The erector did not follow the Building Component Safety Information Guide<sup>1</sup> to Good Practice for Handling, Installing, Restraining, and Bracing of Metal Plate Connected Wood Trusses, by using a spreader bar to hoist the trusses since they were over 60 feet long (see Attachment A). Wood trusses were found twisted and bent (or buckled) (see Figure 15). The mid-panel splice at the bottom chord of the west-most truss was damaged due to out-of-plane buckling during hoisting (see Figure 16).

3. The 70 feet long trusses were not properly hoisted. The trusses were prone to be overstressed during rigging due to out-of-plane buckling (i.e., twisting and bending), likely damaging the wood trusses and resulting in an unsafe condition.

Jeff Brown Construction and its subcontractor, Top Rank, failed to follow the generally accepted standard industry practice of storage and hoisting of trusses; providing temporary top chord lateral restraints, diagonal and web member plane diagonal bracings; and proper ground bracings during erection of the trusses, in accordance with the BCSI, produced by the Structural Building Components Association.

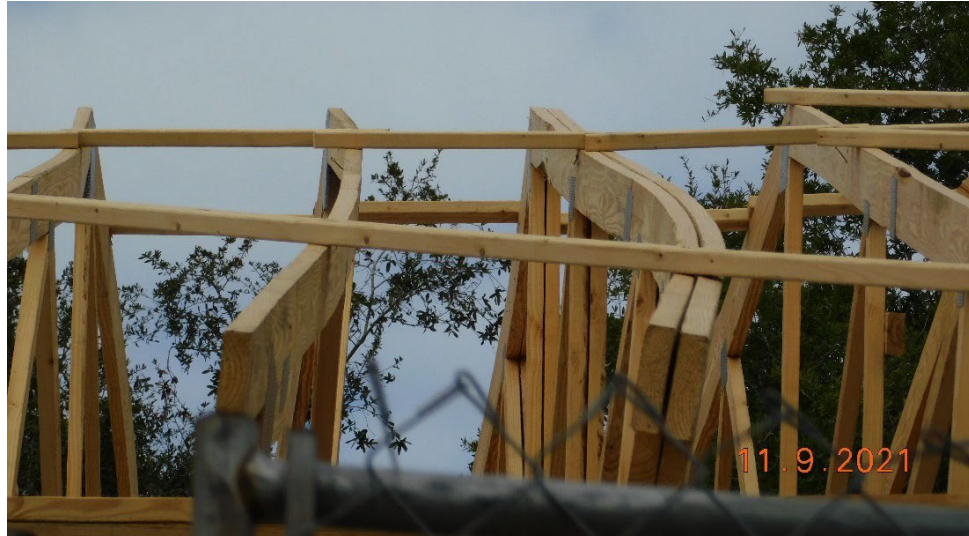
Figure 17 – Buckled trusses

Photographs taken after the incident show that the trusses that remained in place at the east side of the building were buckled as installed (see Figure 17). Since these trusses were far away from those that collapsed, it is believed that the buckling of these trusses was likely not due to the collapse.

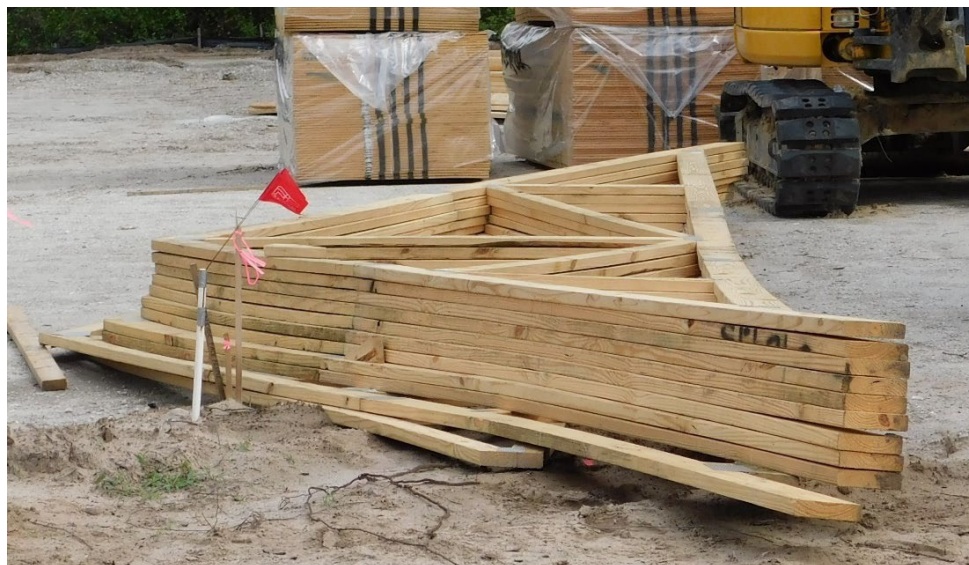
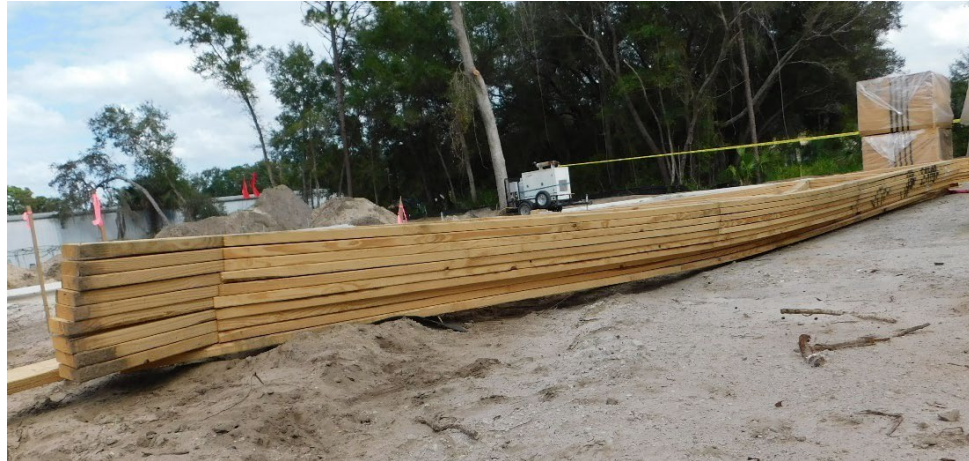
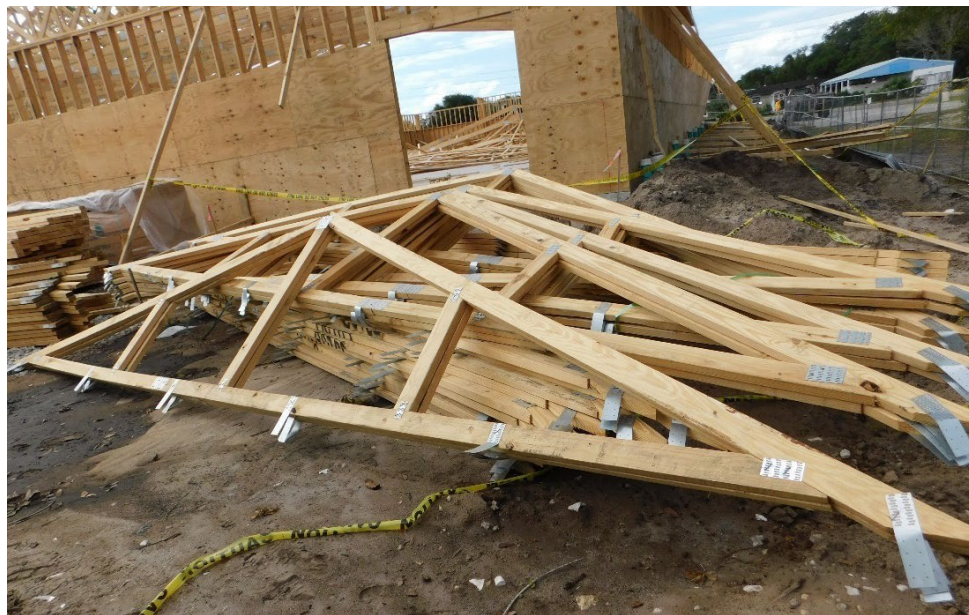
Figure 18 – Incorrect jobsite storage of trusses

During OSHA’s field investigations, it was observed that wood trusses were stored incorrectly at the jobsite, in that the trusses were unloaded on rough terrain, which caused out-of-plane bending of the trusses (see Figures 18 to 20).

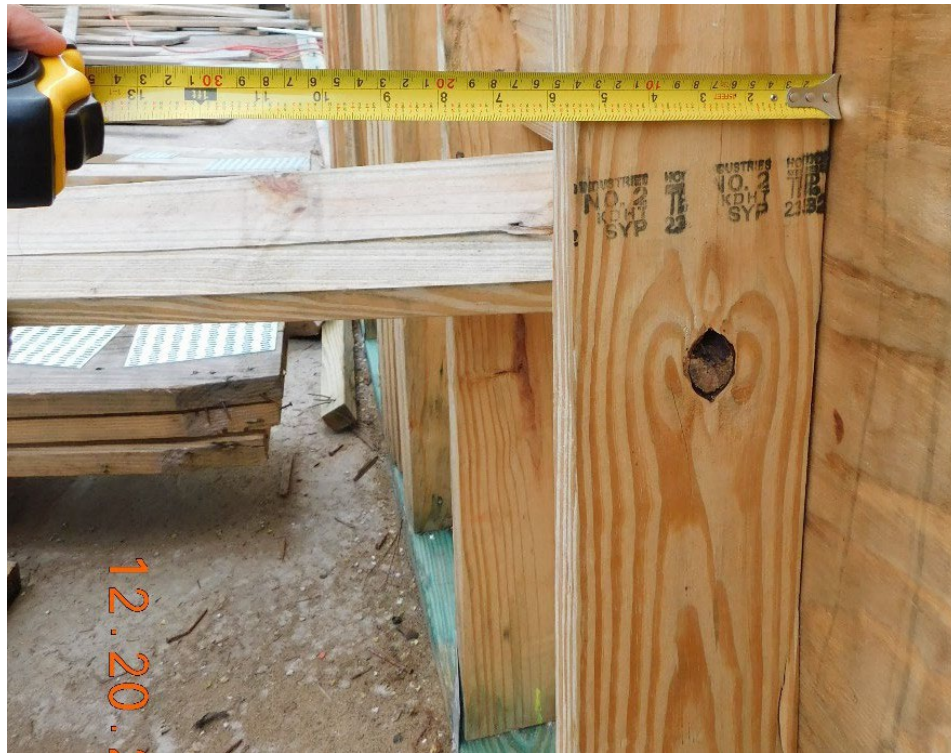
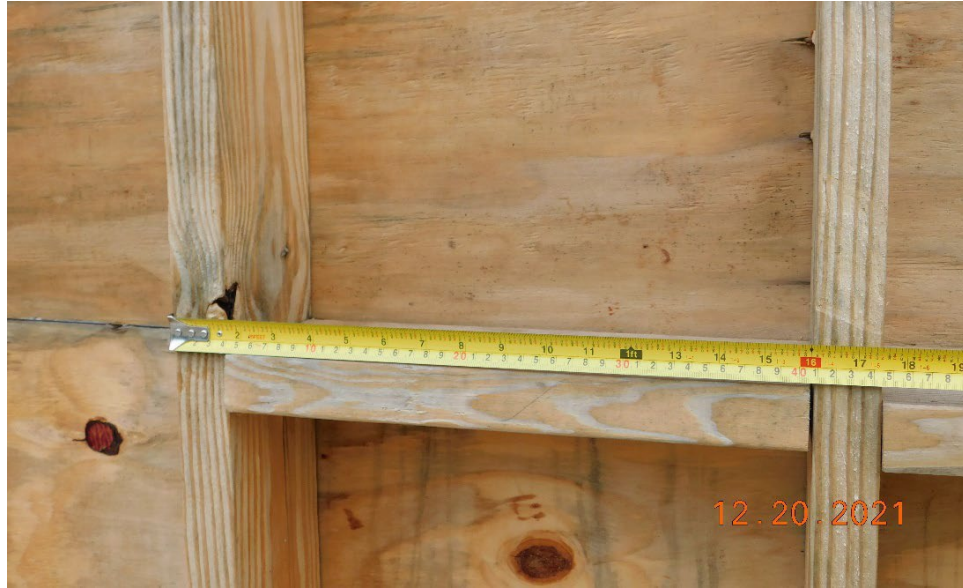
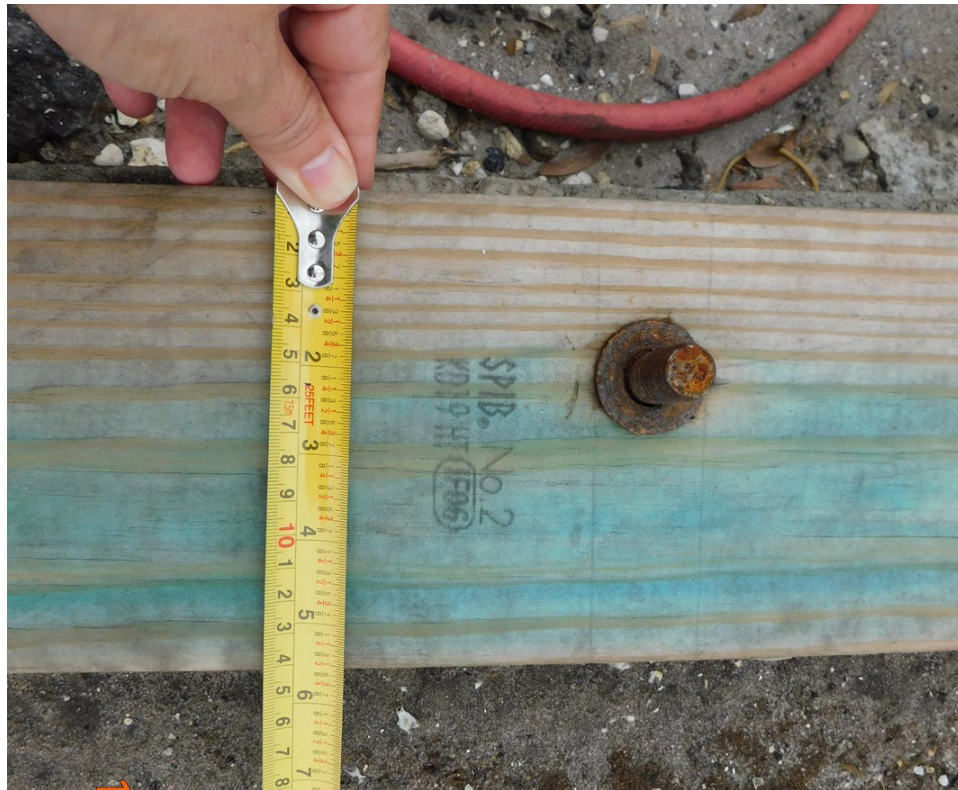
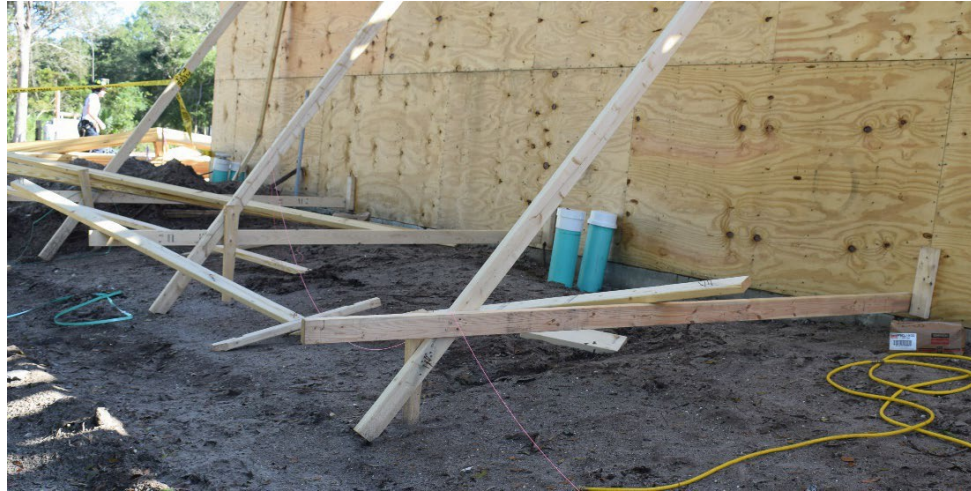
Figure 21 – Bearing wall frame – studs

The wall framing, consisting of 2x6 lumber studs placed at 16 inches on center, was structurally sufficient and code compliant as designed. The building structural design required 2-2x6 (double) top plates and 1-2x6 (single) pressure treated bottom plates for the wall framing. The splices of the double top plates were staggered. This type of framing is considered conventional light framing and is in prescriptive compliance with the building code. During its field inspection, OSHA verified the dimensions and lumber grade used to build the frames (see Figures 21 to 23). OSHA observed diagonal braces installed on the exterior side of the walls (see Figures 3, 5, 8, 10, and 24). The bearing walls did not collapse, although the west portion of the north bearing wall was tilted outward (see Figures 10, 11, 13, and 20). Therefore, the north and south bearing walls did not appear to be a root cause of the collapse of the trusses.

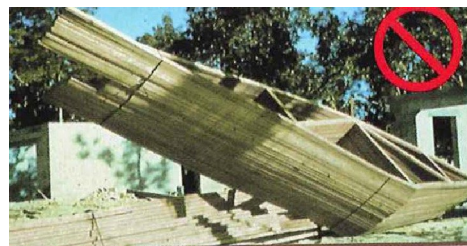
PHOTO B1-4  
PHOTO B1-4

**(S) DO NOT** lift banded Trusses by the banding.

**(S) DO NOT** store unbraced bundles upright.

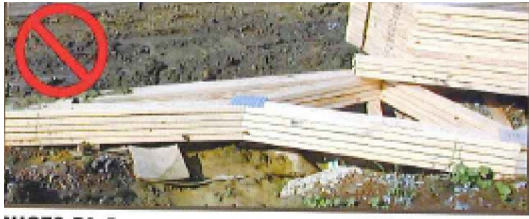
PHOTO B1-5

• **© DO NOT** store Trusses on uneven ground.

If Trusses are stored vertically, they shall be braced in a manner that will prevent tipping or toppling.
