## Accident - Bridge collapse in North Carolina

On April 14, 2021, at approximately 5 p.m., the last span of the Herbert C. Bonner Bridge (Bonner Bridge) under demolition collapsed in Dare County, North Carolina. An employee of PCL Civil Constructors, Inc. (PCL), engaged in the steel cutting, was killed. The collapsed span was the navigation span of the Bonner Bridge measuring 180 feet long, 24 feet wide, and approximately 60 feet above sea level, with a total weight of 980 kips.<sup>1</sup>

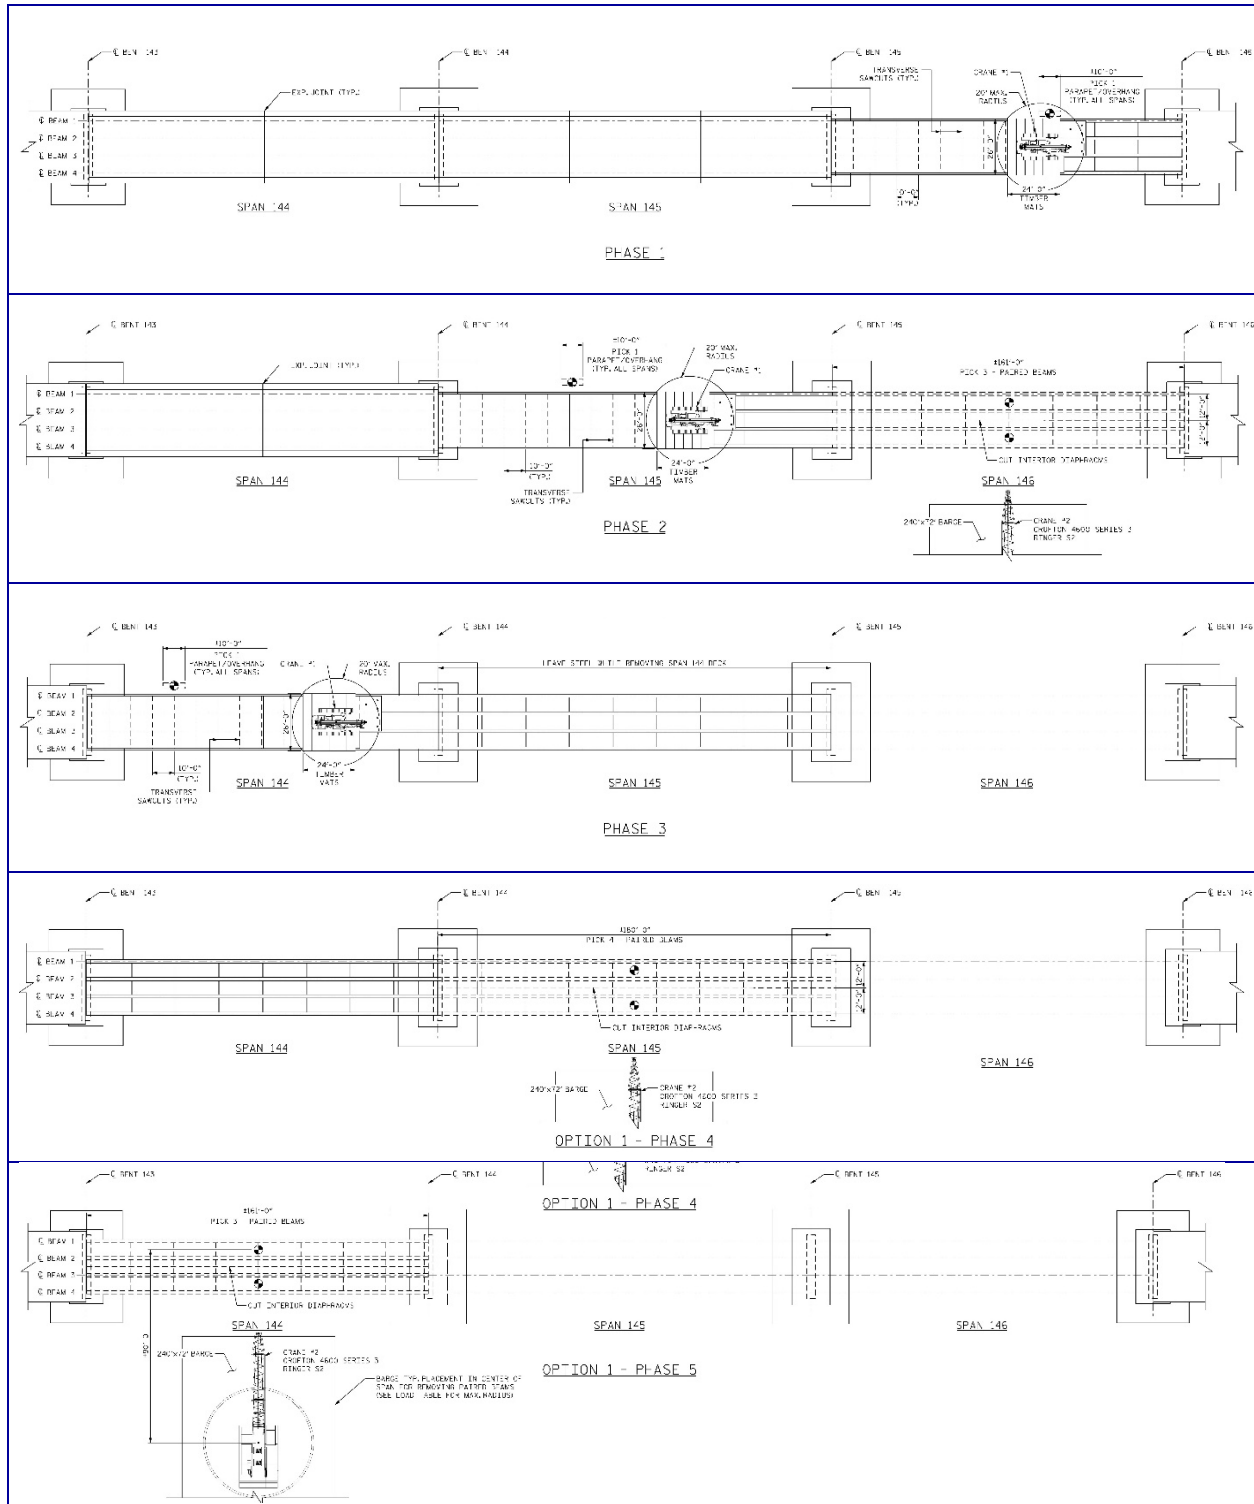
Figure 10 – Demolition sequence developed by KCI

KCI planned to demolish the three high-rise spans in five phases. The demolition plan is reproduced in Figure 10 and outlined in the steps below:

Even though the demolition plan illustrated that demolition begins on Span 146 (see Figure 10), the demolition could start on either the northernmost Span 144 or the southernmost Span 146 and extend through the middle Span 145 down to the other end span as per the note on the demolition plan, as reproduced below.

ORDER OF STEEL SPAN DEMOLITION MAY BE REVERSED, HOWEVER  
STEEL BEAMS AND DIAPHRAGMS IN SPAN 145 MUST REMAIN IN  
PLACE UNTIL DECK ON FINAL EXTERIOR SPAN (SPAN 144 OR 146)  
IS REMOVED.

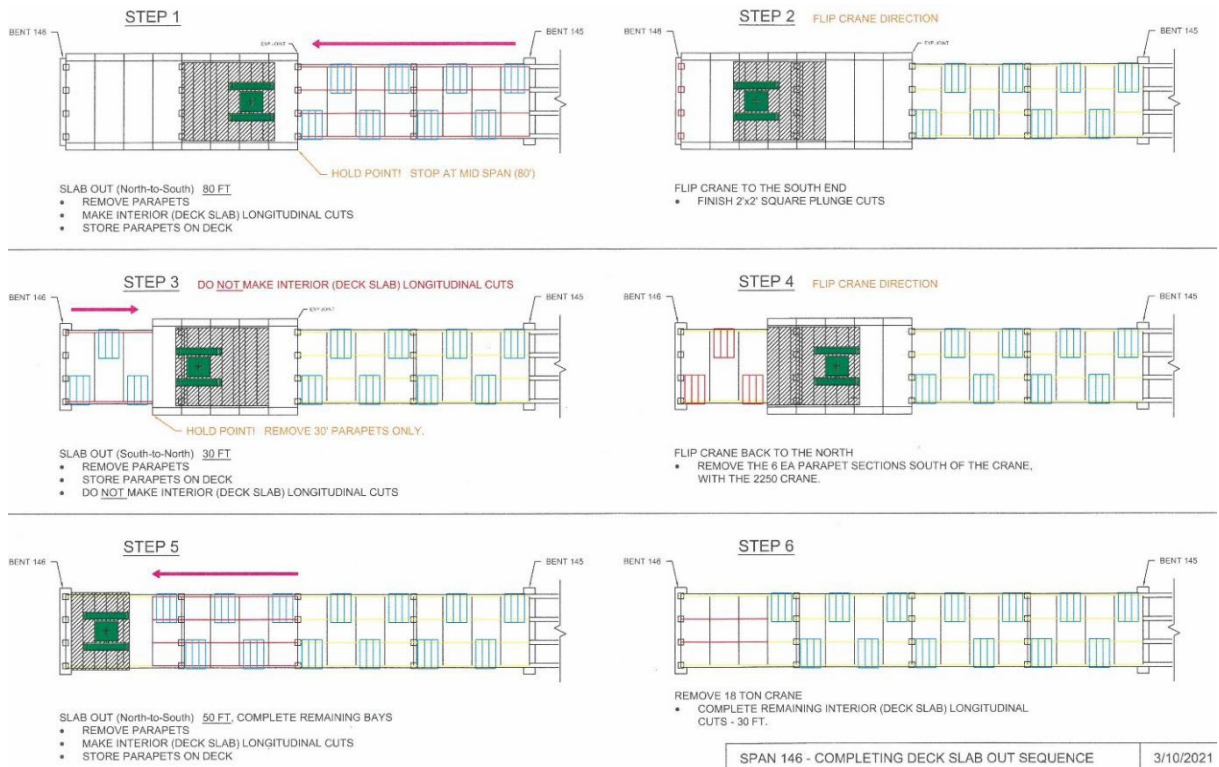
Figure 19 – PCL’s demolition plan for Span 146 deck removal

March 10, 2021, PCL developed a plan for stacking deck overhang and parapet segments on Span 146 (see Figure 19). Figure 20 illustrates that PCL placed all overhang and parapet segments on Spans 145 and 146.

PCL neither consulted with KCI regarding PCL's demolition plans created on March 10 and 12, 2021, nor submitted the plans to NCDOT.

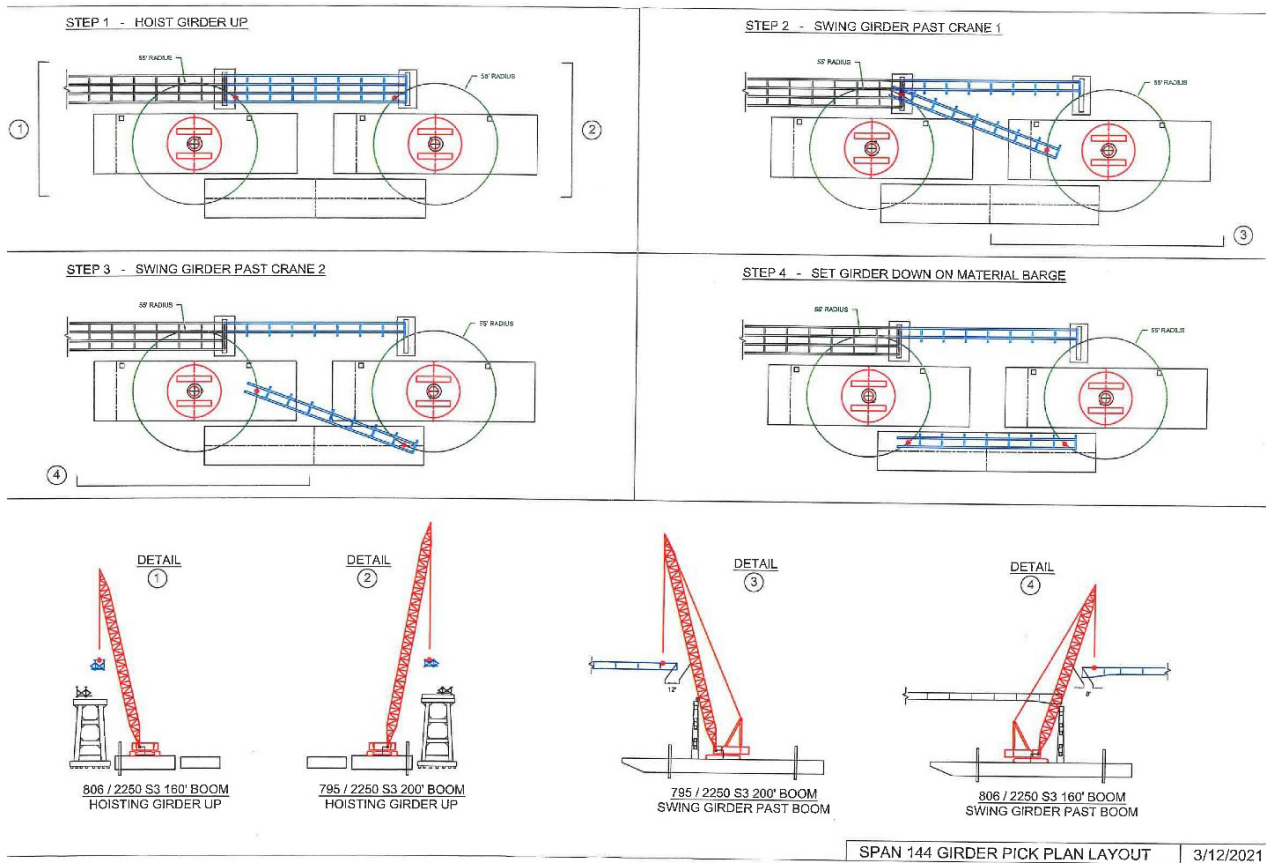
Figure 21 – PCL’s demolition plan for Span 144 girder removal

March 12, 2021, PCL developed a plan for the removal of the steel girders in Span 144 (see Figure 21).

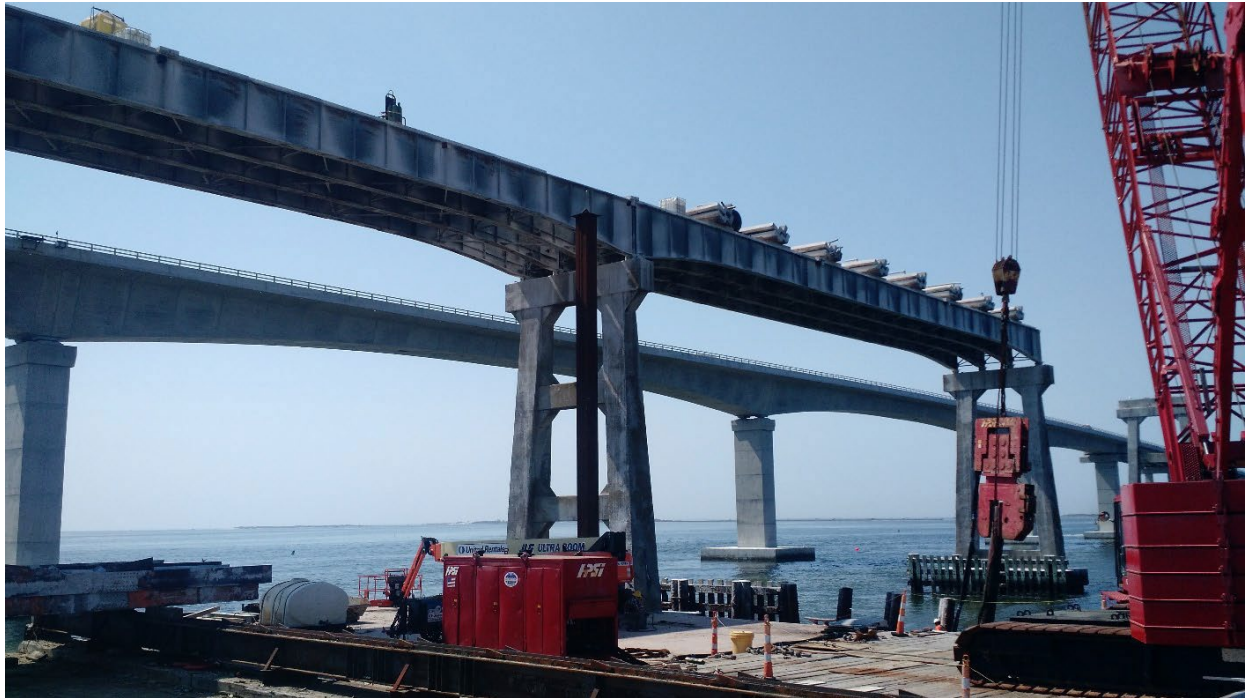
April 7, 2021, PCL started removing the deck in Span 146 (see Figure 23).

April 12, 2021, PCL started dismantling steel girders in Span 146 (see Figures 23 and 25).

Figure 23 – Parapet segments in Span 146 had been removed  
(photographed on 4/7/2021)

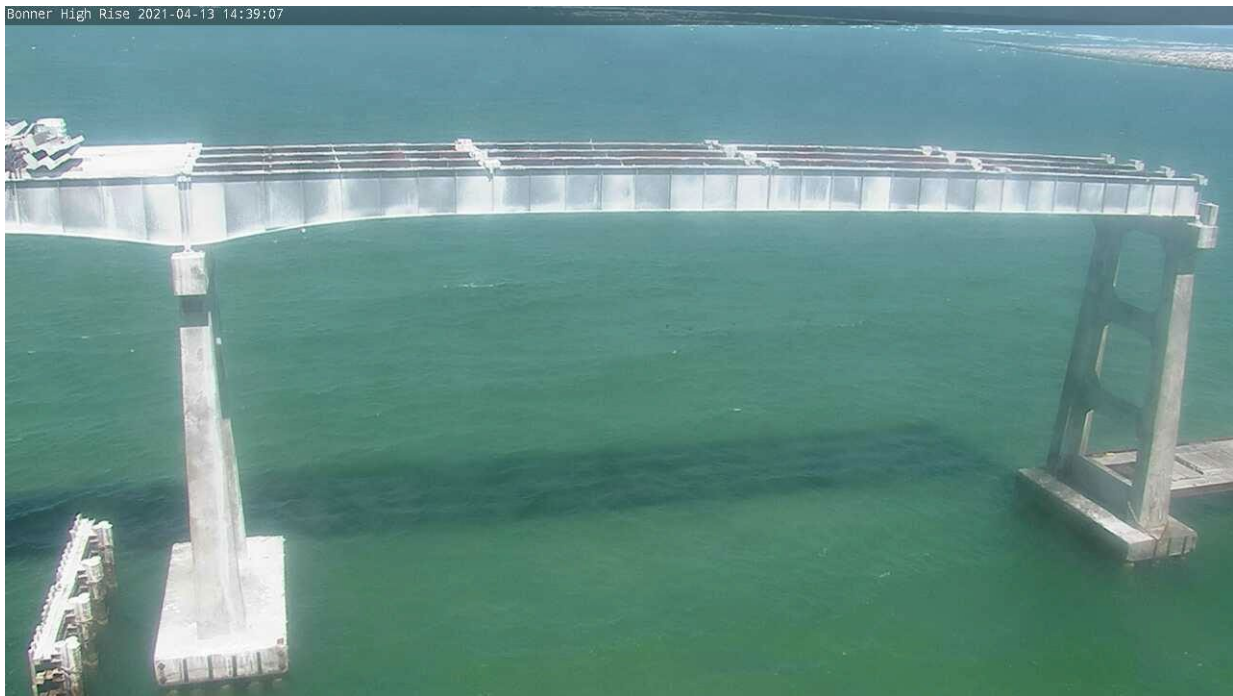
Figure 24 – Concrete in Span 146 had been removed  
(photographed on 4/13/2021 by NCDOT)

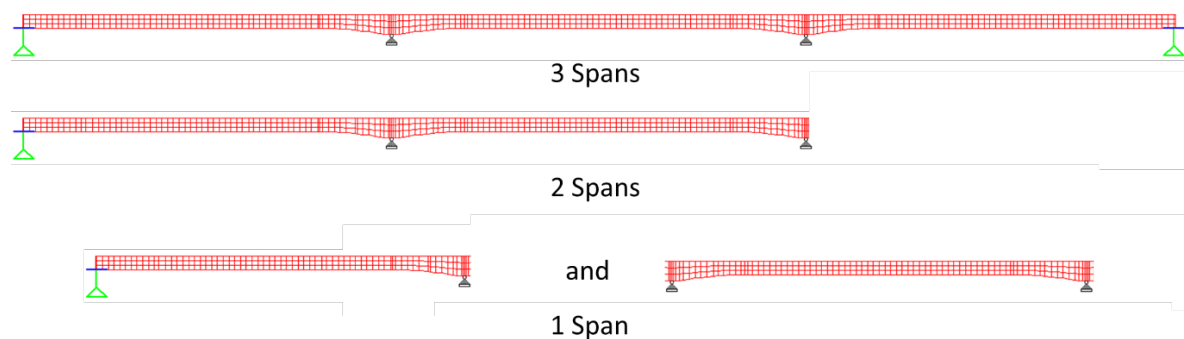
Figure 32 – FE model of steel girders in three spans

Figure 32 illustrates the 3D FE model of the steel girders created in STAAD.Pro using coarse meshes<sup>10</sup> for all analysis cases in Table 1. Main plate girder components, including flanges, webs, and stiffeners, were modeled using 4-noded (quadrilateral) plate elements, which had both attribute membrane (in-plane effect) and bending (out-of-plane effect). The supports at both ends of Span 145 were pin supports, and the supports at Bents 143 and 146 were rollers, as shown in Figure 32.

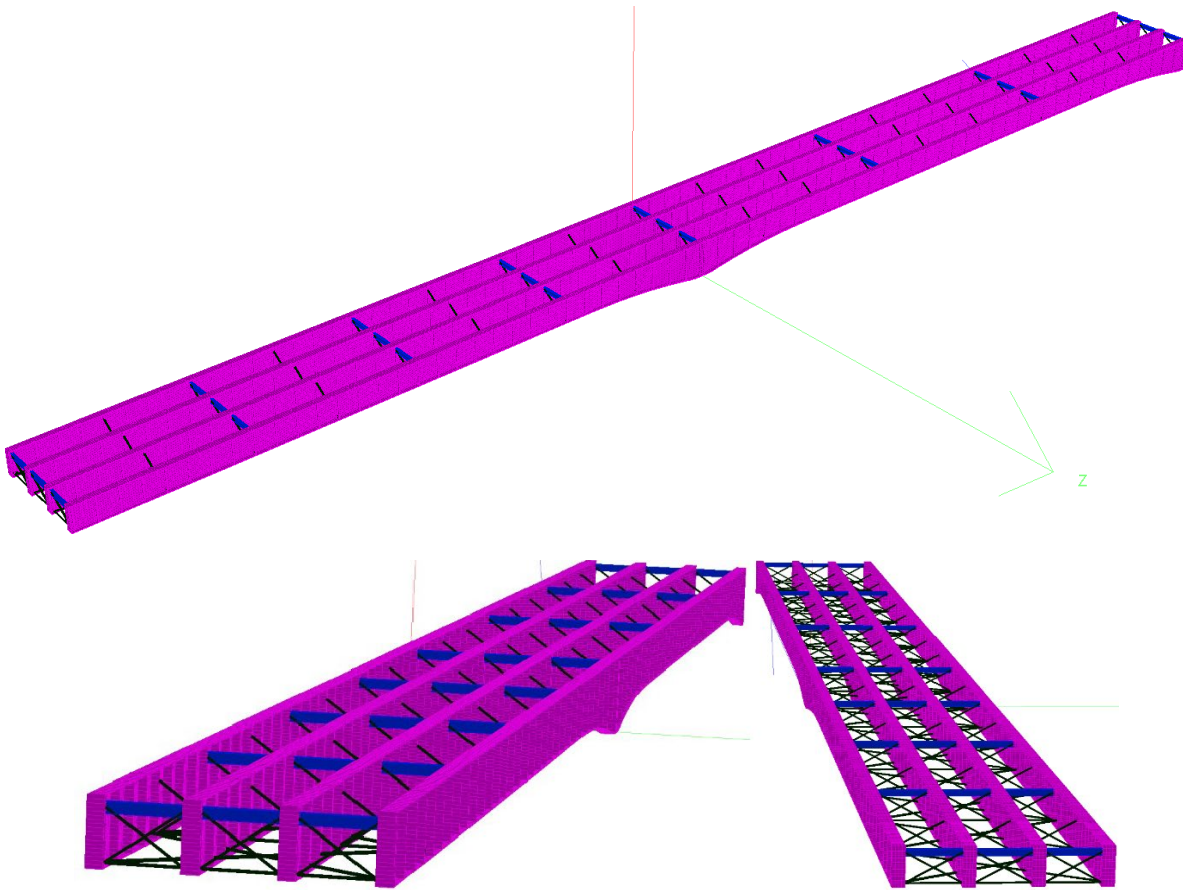
Figure 33 – FE model of steel framing in Spans 145 and 146

For Cases 7 to 9 in Table 1, 3D FE models of the complete steel framing, including steel girders and lateral and vertical bracing, were developed in STAAD.Pro using fine meshes<sup>11</sup> (see Figure 33). Uniaxial tension only TRUSS type elements were used to model the lateral and vertical cross-bracing between two adjacent plate girders.

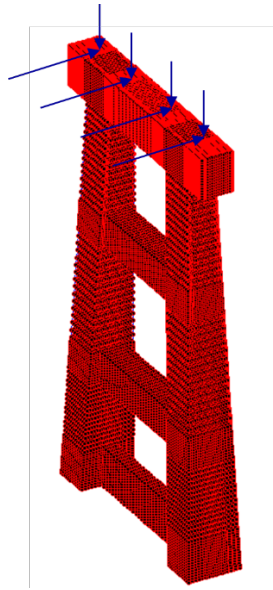
Figure 34 – 3D FE model of Bent 144/145

Figure 34 shows the 3D FE solid model for Bents 144 and 145 developed in STAAD Pro. Support reactions from the girder analyses were applied as vertical and horizontal concentrated forces at the four bearing supports on the top of the bent (blue arrows in Figure 34). The column section forces, including axial and shear forces and bending moments, were obtained after the analyses. Hand calculations were also performed using the column section and material properties from the as-built drawing to determine the load-carrying capacities of the columns (see Figure 35). We did not consider concrete deterioration and reinforcement corrosion in the columns when determining their load-carrying capacities.
