Accident- Tank Farm explosion and fire in Deer Park, Texas

The CSB determined that the cause of the incident was the release of flammable butane-enriched naphtha vapor from the failed Tank 80-8 circulation pump, which accumulated in the area and ignited, resulting in a fire.

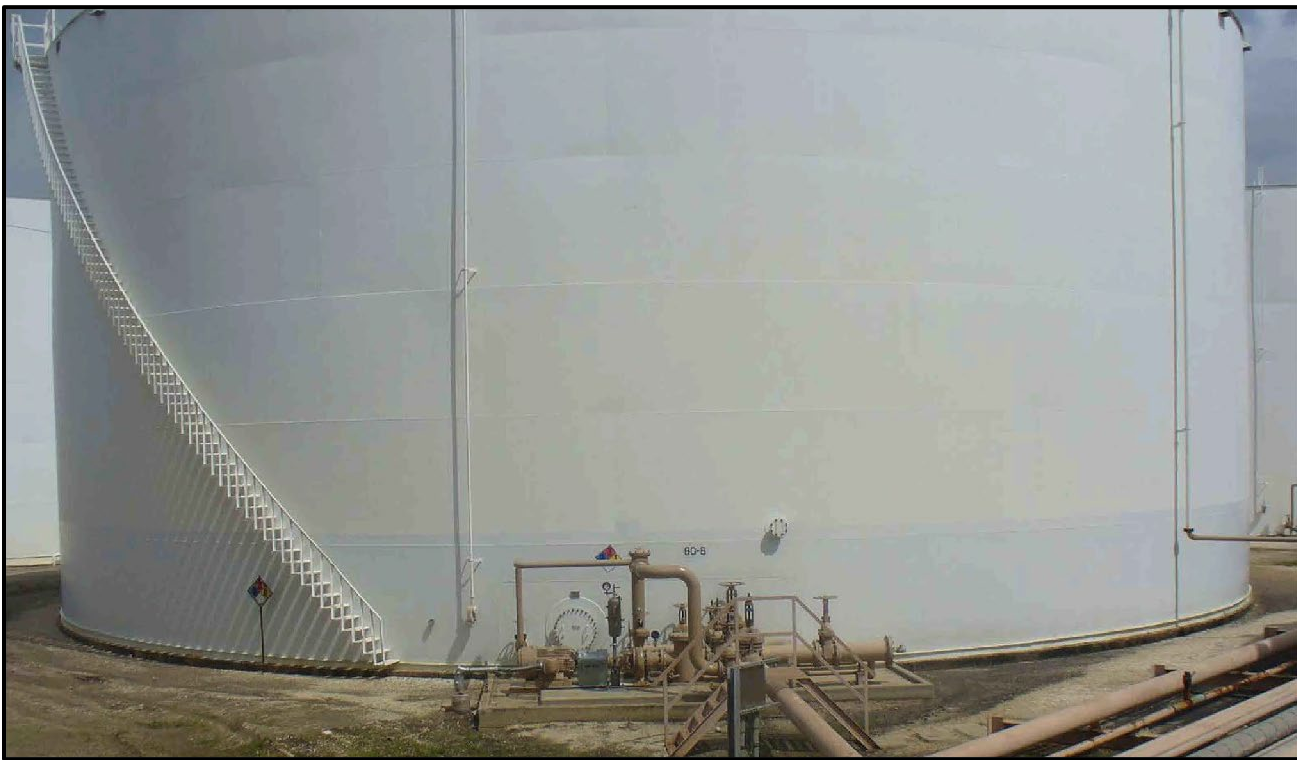
The incident occurred in what was commonly referred to as the First & Second 80's tank farm at the ITC Deer Park terminal (**Figure 3**). The First & Second 80's tank farm consisted of fifteen (15) 80,000-barrel (3,360,000-gallon) capacity aboveground atmospheric storage tanks situated within a common containment area that measured approximately 732 feet in length by 449 feet in width. The storage tanks measured 110 feet in diameter and 48 feet in height and were arranged in a 3 x 5 grid pattern, oriented in the east-west direction lengthwise. The aboveground atmospheric storage tank involved in the initial fire, Tank 80-8, was positioned in the center of the First & Second 80's tank farm (**Figure 4**).

Figure 4. Tank 80-8, shown in 2007. (Credit: ITC)

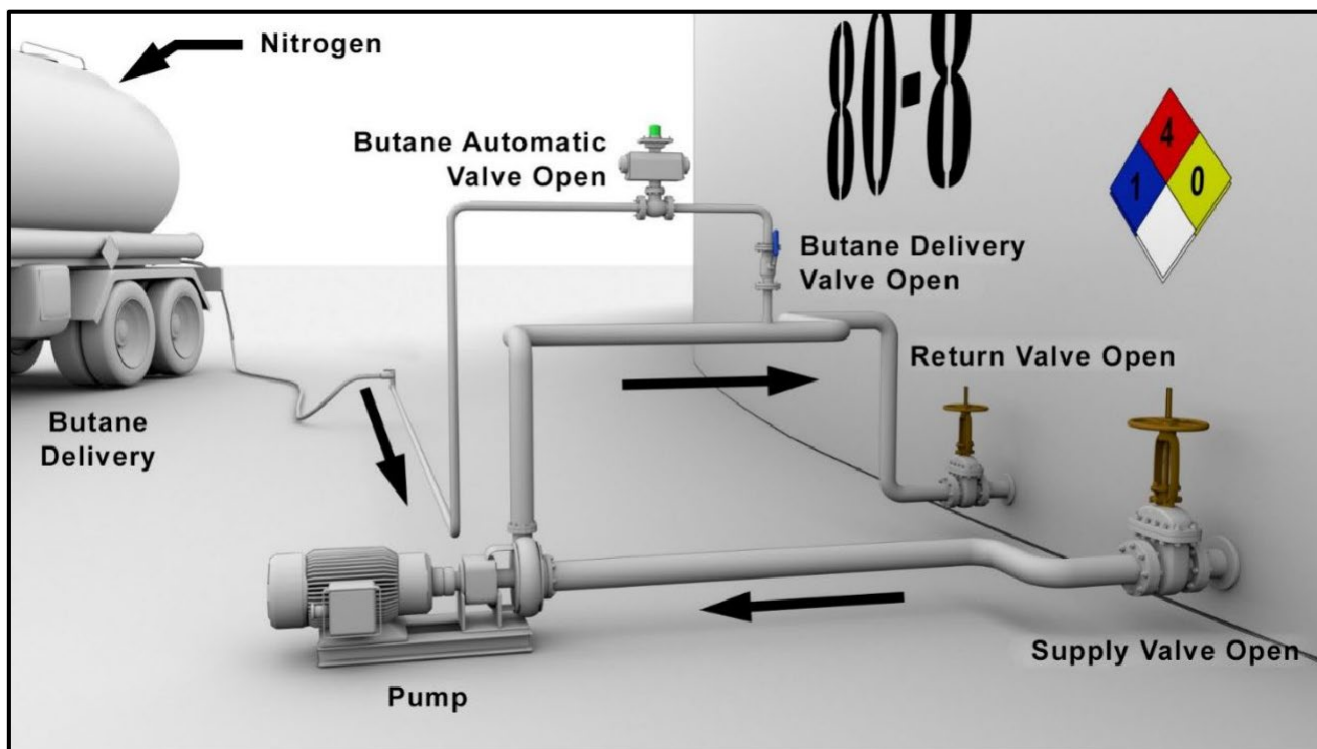
The Tank 80-8 Truck Butane Injection System originated at the 80's truck rack, located southwest of the tank farm (**Figure 5**), and terminated at an injection point in Tank 80-8's circulation line (**Figure 6**). The system was

designed so that the butane unloading operation could not begin unless the Tank 80-8 circulation pump was turned on, to ensure that butane-enriched naphtha product was circulating in the line. Once this condition was met, an ITC operator positioned at the 80's truck rack could then open the butane injection control valve to commence butane unloading operations. Nitrogen was used to unload the butane from the truck, and through two-inch piping to the Tank 80-8 circulation line, at which point the butane combined with the existing butane-enriched naphtha product in the tank. The Tank 80-8 circulation pump remained on throughout the unloading activity, and for several hours afterward, in order to facilitate the mixing of the naphtha and butane.

Figure 6. Simplified schematic showing ITC's butane injection system prior to 2016. The arrows in the figure show the butane flow direction and the naphtha product circulation path through the piping. Note: schematic not to scale. (Credit: CSB)

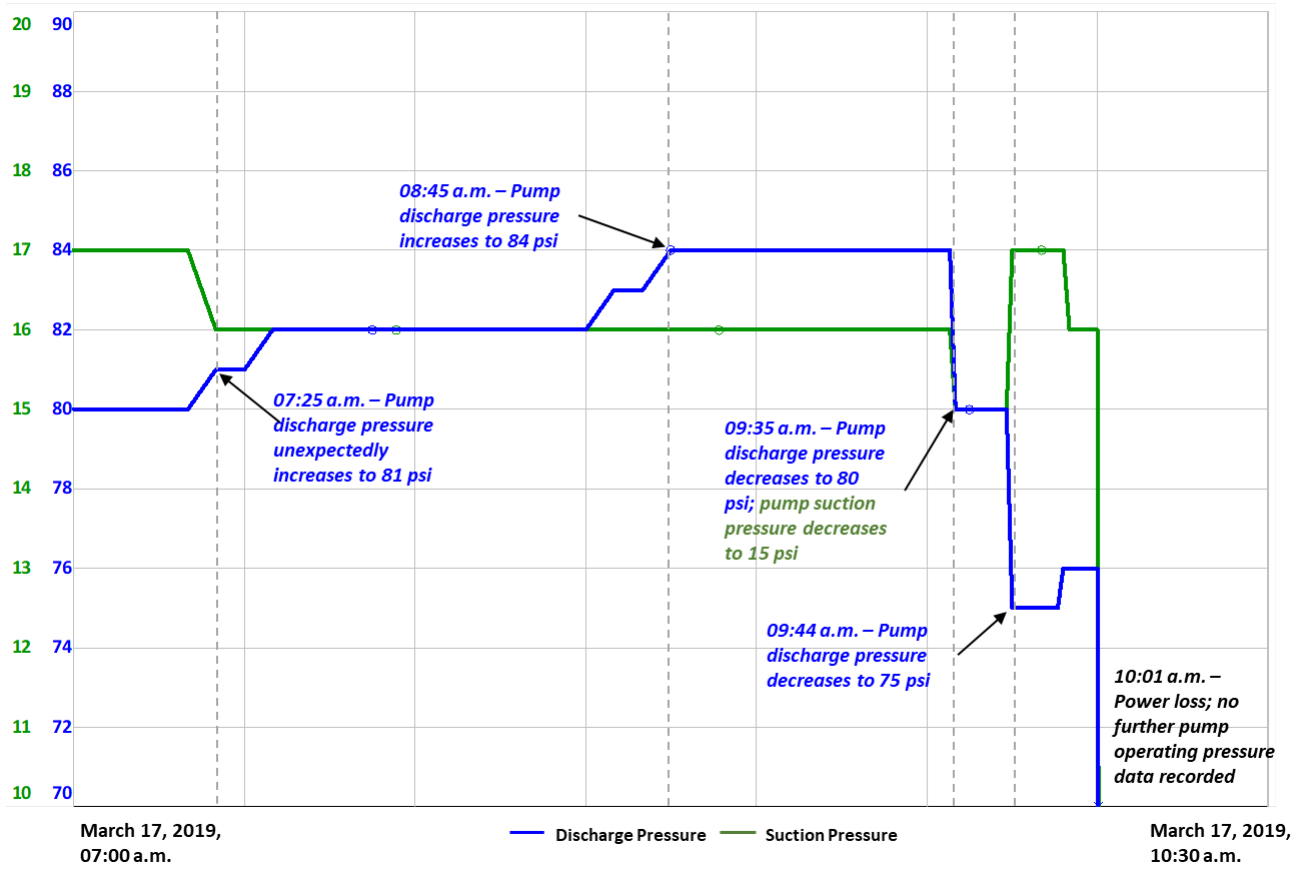
Tank 80-8 Pump Discharge Pressure & Suction Pressure

On the morning of March 17, 2019, as the Tank 80-8 circulation pump continued to operate, distributed control system (DCS) data for the tank indicated a series of unanticipated changes in the monitored operating pressures, flow rate, and tank volume. Beginning at approximately 7:25 a.m., the pump discharge pressure began to increase with no change in operation having occurred (**Figure 7**). By 8:45 a.m., the pump discharge pressure had gradually increased from 80 psi to 84 psi. At approximately 9:30 a.m., when the mechanical seal on the pump failed and butane-enriched naphtha product began to release to the atmosphere, the recorded tank level began to decrease, and recorded average flow rate^a for the tank, automatically calculated from changes in tank level measurements, began to increase (**Figure 8**). At approximately 9:35 a.m., the pump discharge pressure abruptly dropped to 80 psi, and within the next 10 minutes dropped further to 75 psi. At the same time, the recorded average flow rate of material from the tank had increased to about 158 barrels per hour (bph), and by 9:44 a.m. had increased to over 388 bph.

Figure 7. Recorded data historian trends showing recorded pump operating pressure data for Tank 80-8. (Credit: CSB)

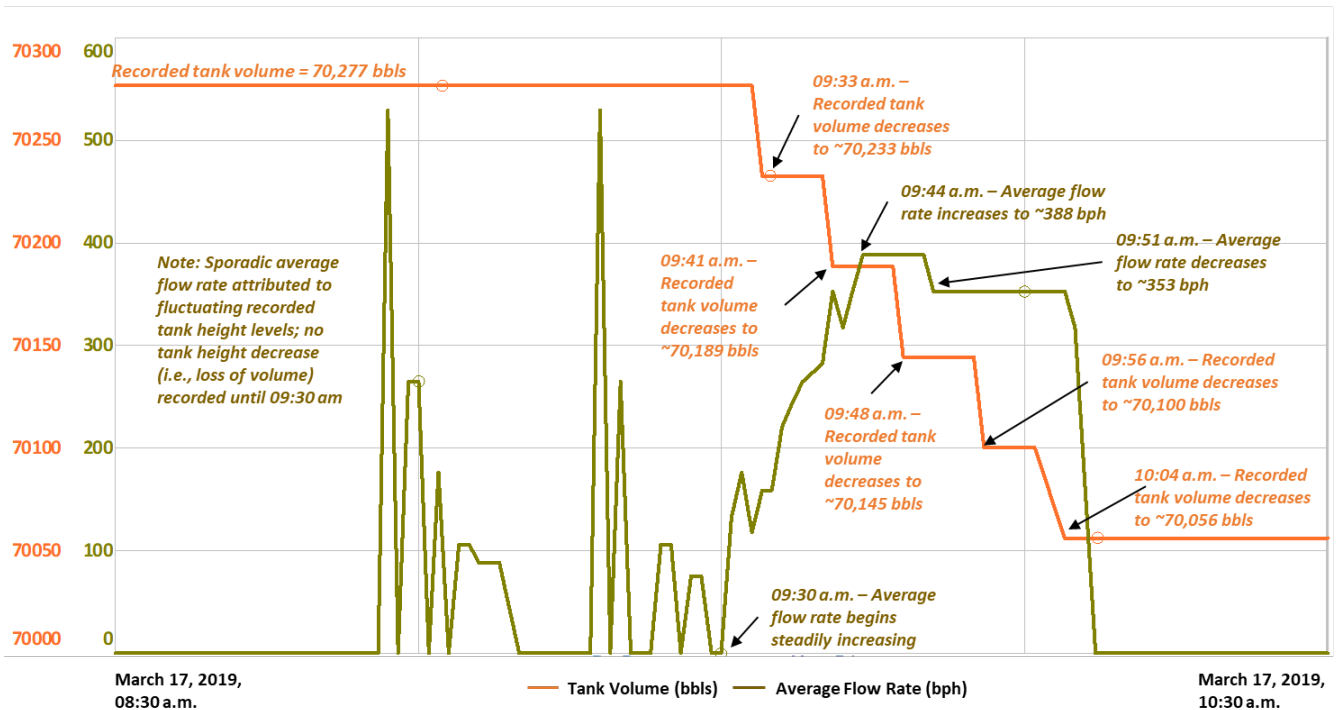
Tank 80-8 Recorded Tank Volume & Average Flow Rate

Figure 8. Recorded data historian trends showing recorded average flow rate and tank volume data for Tank 80-8. (Credit: CSB)

Between 9:30 and 10:00 a.m., the recorded tank volume^a in Tank 80-8 decreased by more than 177 barrels as the naphtha product continued to release from the failed pump.^b At 10:00:46 a.m., approximately 30 minutes after the release began, the butane-enriched naphtha product releasing from the Tank 80-8 piping manifold ignited (**Figure 9**). No operators were working outside in the First & Second 80's tank farm during this time frame. The acting shift manager was working in the adjacent Third 80's tank farm that morning and an operator was working in the nearby 100's tank farm. However, neither of them heard, saw, or smelled anything out of the ordinary during the time of the release. The First & Second 80's tank farm was not equipped with a gas detection system.

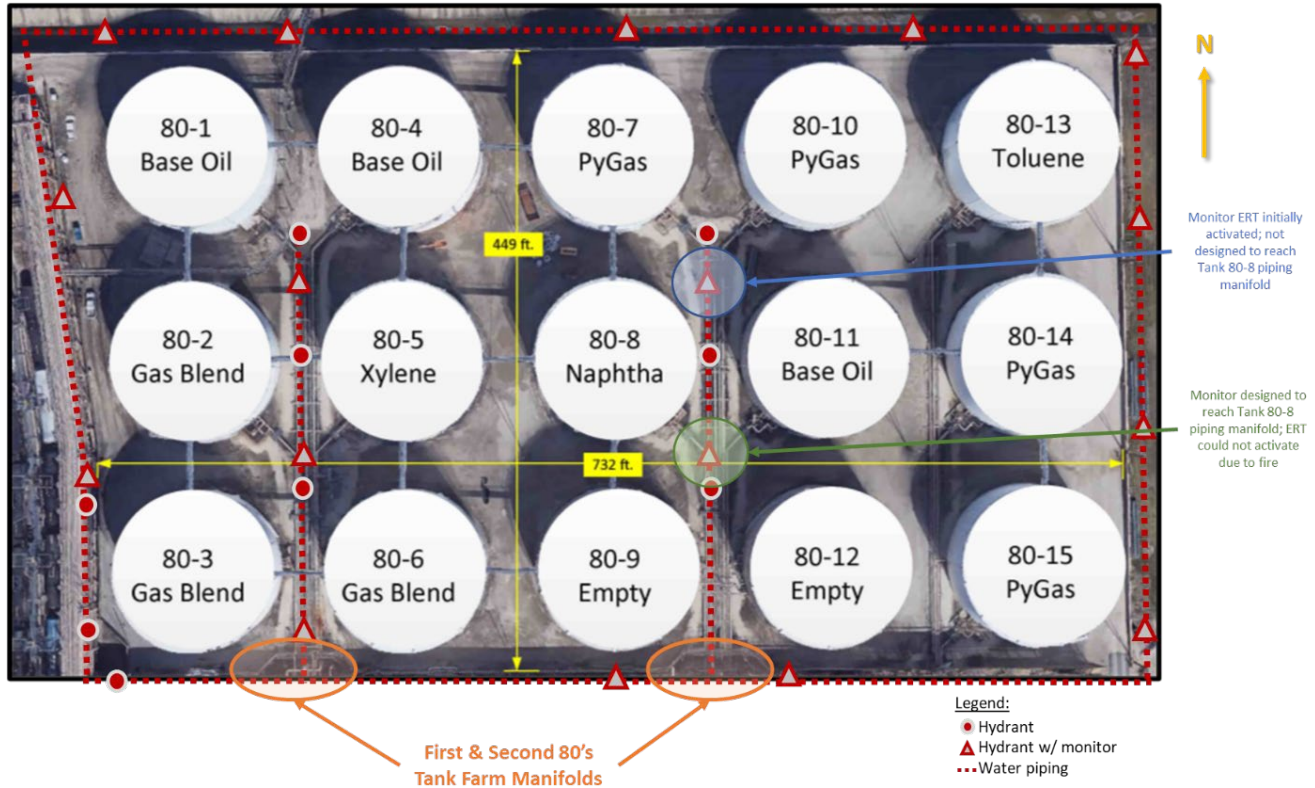
Figure 10. First & Second 80's tank farm layout, including products contained in the tanks at the time of the incident and positions of fire water equipment. (Credit: ITC, annotations by CSB)

^f These five additional tanks included Tanks 80-2, 80-3, 80-6, 80-9, and 80-11, which contained gasoline blendstock and base oil. Flammable vapors ignited along the rooflines of Tanks 80-2, 80-3, 80-6, and 80-9, causing fire to expel from the vents located near the top of the tanks. At this time, the fire involving Tank 80-11 burned at ground level in the area of the piping manifold. Sometime before 5:30 a.m., an additional tank containing toluene, Tank 80-13, became involved in the fire at ground level but was quickly extinguished (Figure 10).

^g For example, Tanks 80-14 and 80-15, which caught fire in the early hours of March 19, were located in the southeast corner of the tank farm (Figure 10) and contained Pygas, a highly flammable liquid.

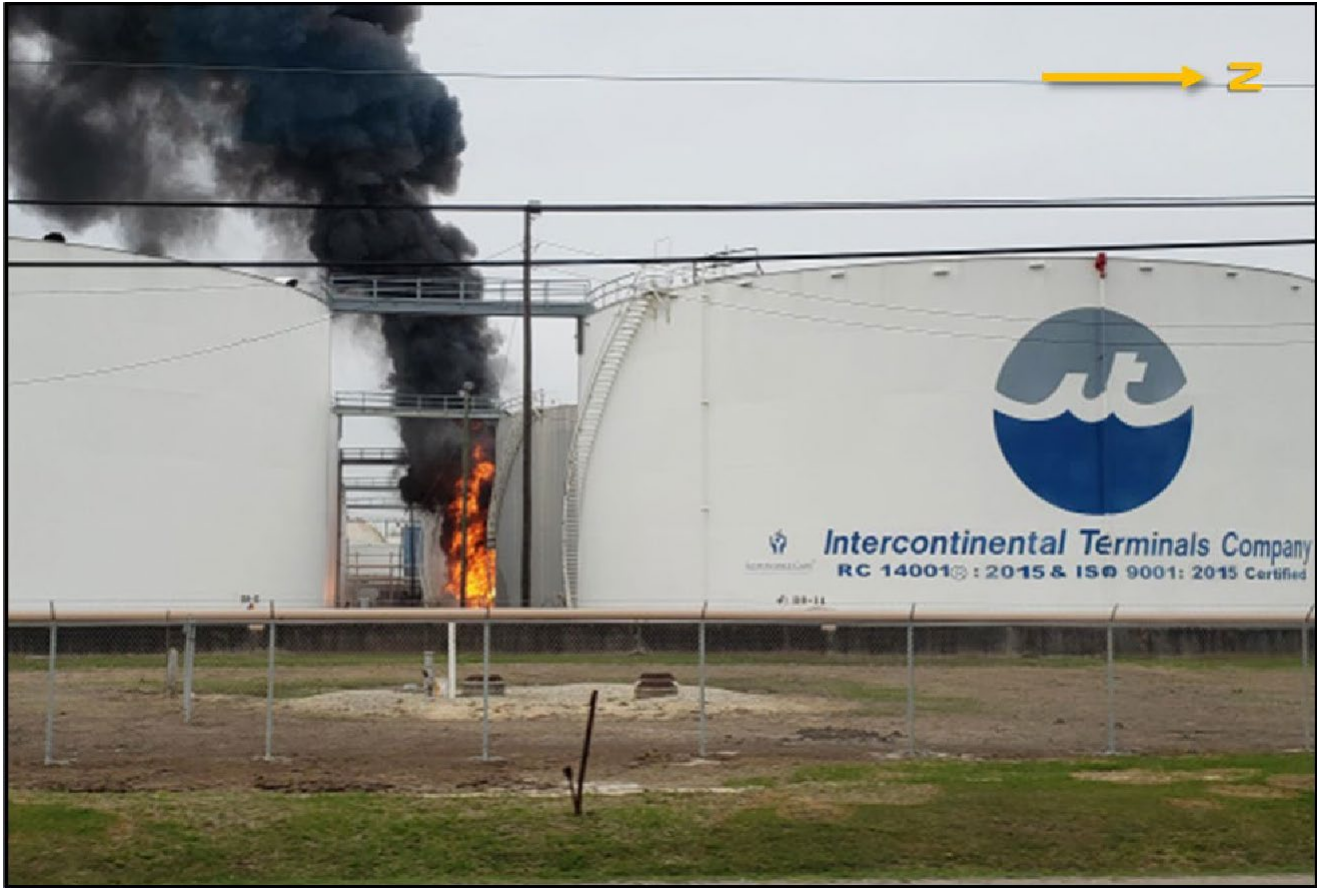
When the VP of Safety arrived, his initial observation of the scene was a three-dimensional fire^a involving the Tank 80-8 piping manifold (**Figure 11**). A liquid pool fire at ground level fully engulfed the Tank 80-8 piping manifold located on the southeast side of the tank, and a pressure fire shot flames horizontally from piping or a flange located roughly six feet above ground level in the same area. Flames from the fire extended up along the side of the tank toward the rim.

Figure 11. Initial ITC tank fire that ignited at Tank 80-8 on March 17, 2019. (Credit: HCFMO, annotations by CSB)

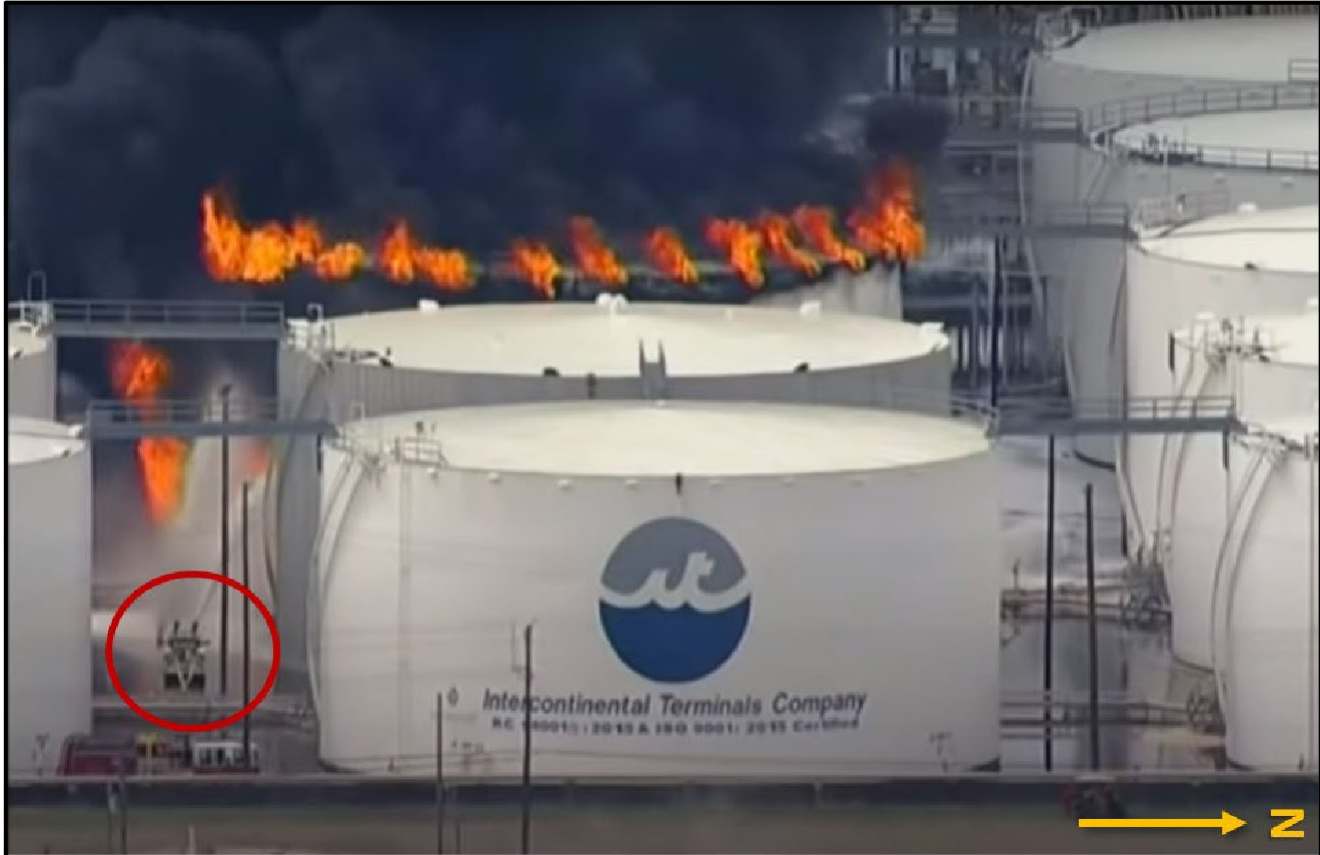
Early response efforts focused on life safety^a and directing water sources at Tank 80-8 and the ground-level fire that engulfed its piping manifold (**Figure 13**). As the fire grew, additional water supply was needed; so, efforts were also underway to establish water supply from neighboring facilities and the Houston Ship Channel via fire boats. Emergency responders continued to work to control the fire; however, it was “growing faster than [they] could do anything.”

Figure 13. The quick attack truck (circled in red) staged between Tanks 80-11 and 80-12 on March 17, 2019. (Credit: Associated Press, annotations by CSB.)

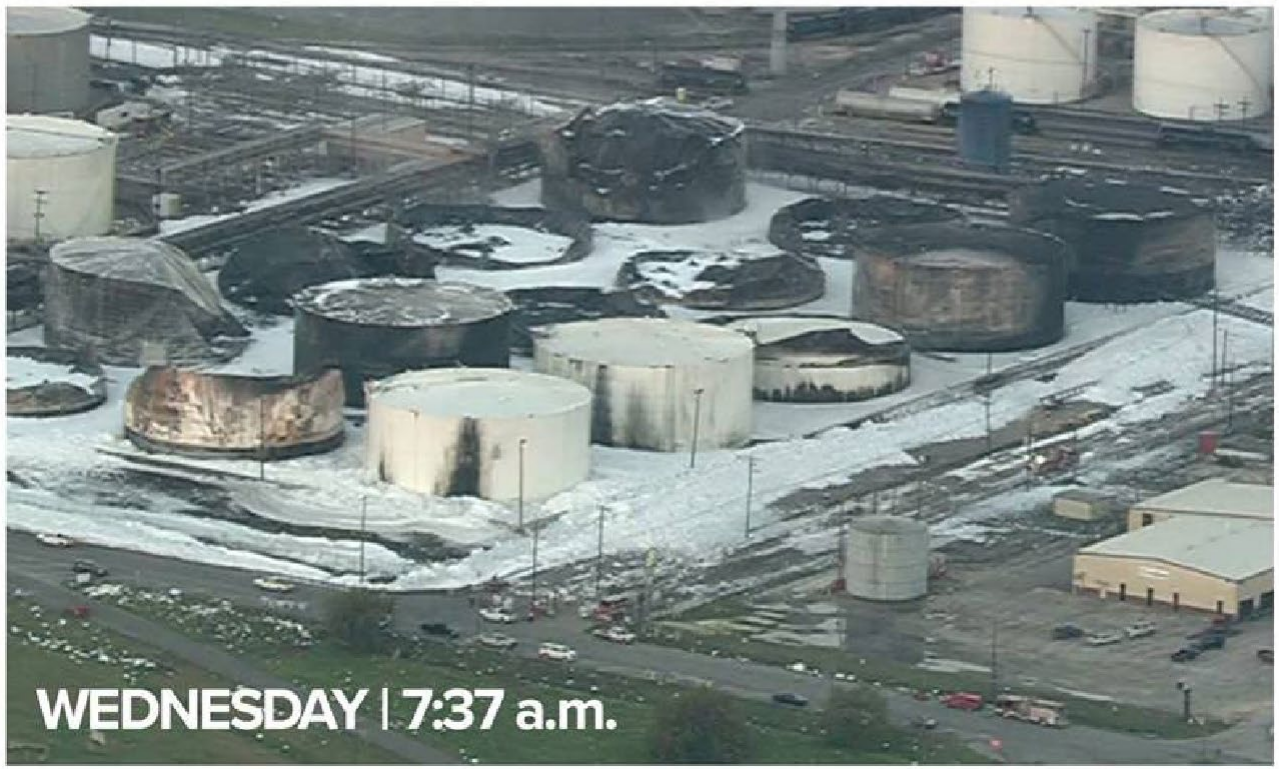
The fire at the ITC Deer Park terminal was extinguished by approximately 3:00 a.m. on Wednesday, March 20, 2019 (**Figure 14**).^h Later that evening, at approximately 5:20 p.m., a flare-up occurred at Tank 80-5 (**Figure 15**). Emergency responders were able to contain the fire quickly.

Figure 14. First & Second 80's tank farm on fire on Tuesday, March 19, 2019, and fully extinguished on Wednesday, March 20, 2019. (Credit: KHOU 11 News)

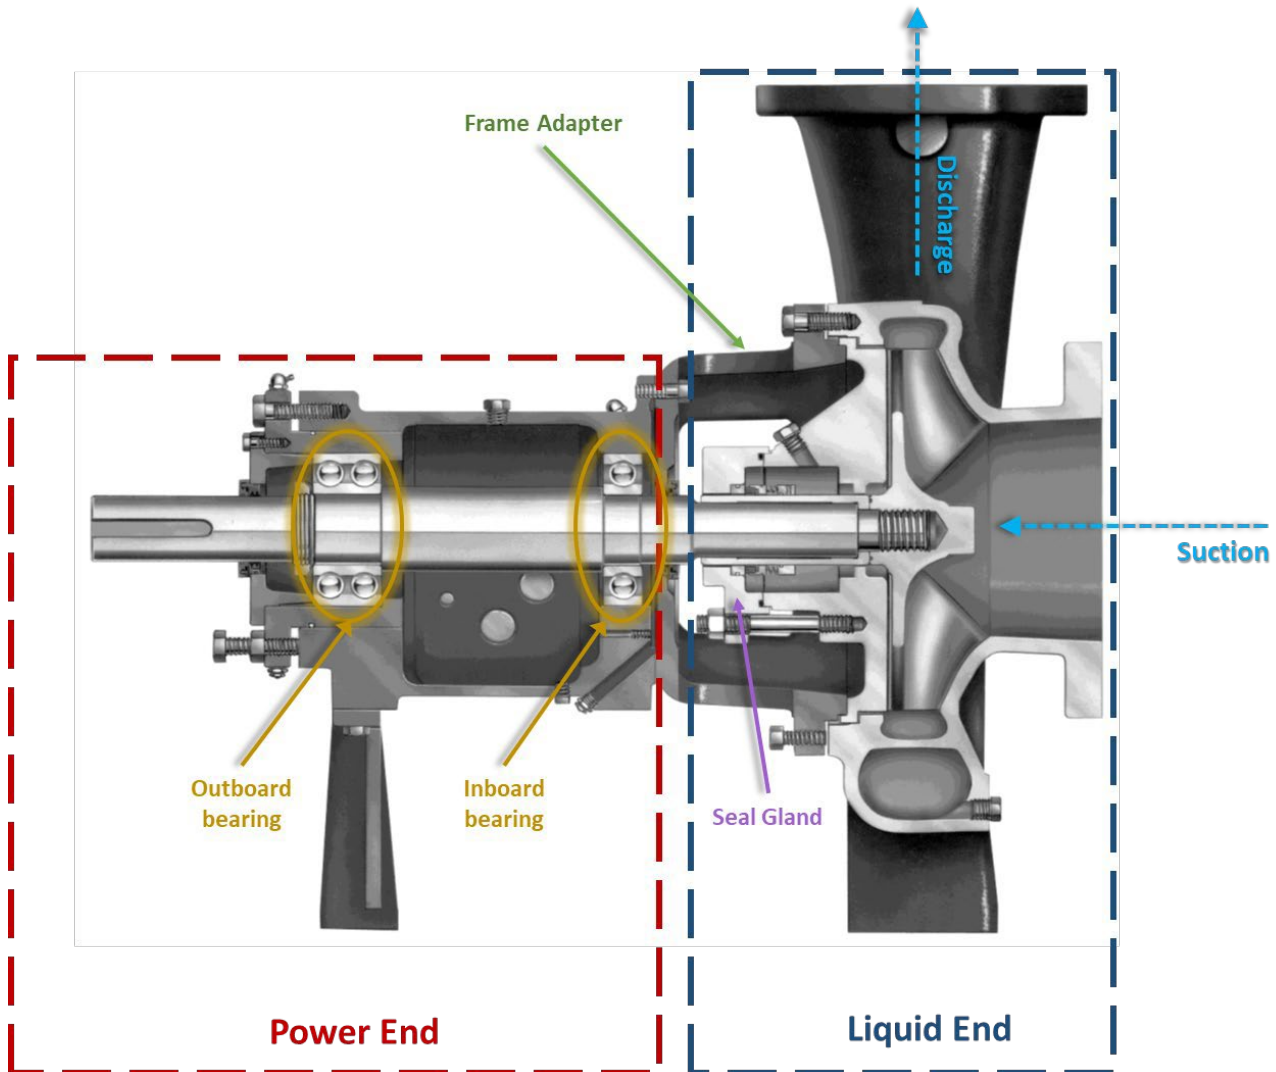
Figure 21. Sectional view of *Goulds Model 3196 XLT-X* chemical process pump. This view identifies the pump's liquid end, power end, and rigid frame adapter. (Credit: *Goulds*, annotations by CSB)

(**Figure 21**). The liquid end was comprised of the casing, impeller, seal chamber, and mechanical seal gland.^a The mechanical seal was designed to contain the butane-enriched naphtha product inside the seal chamber as it flowed through the pump. The seal gland mounted flush to the seal chamber cover and was secured by four gland nuts threaded onto the seal chamber studs that extended through designated slots on the seal gland. The power end was comprised of the bearing frame, pump shaft, two sets of ball bearings, and oil seals. The purpose of the two sets of ball bearings was to support the pump shaft. The inboard bearing was responsible for carrying radial loads,^b and the outboard bearing was responsible for carrying both radial and thrust (axial) loads. The pump shaft extended from the impeller through the seal chamber and bearing frame to the motor coupling.

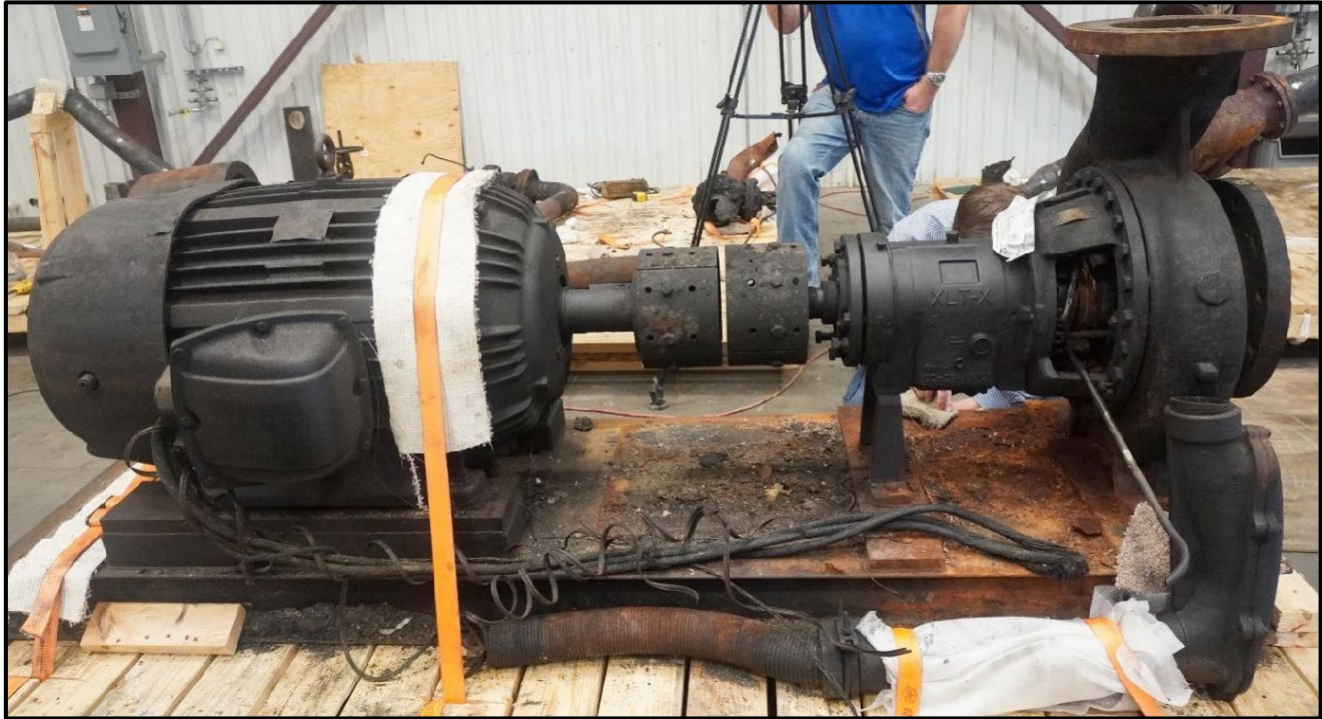
Figure 22. Tank 80-8 pump removed from ITC Deer Park terminal. Pictured is the pump kit on a pallet, as removed from the incident site. (Credit: CSB)

Following the incident, the Tank 80-8 circulation pump skid was transported to a third-party facility for inspection and teardown (**Figure 22**). The pump was fully disassembled to allow for visual examination of its individual components and documentation of their condition. Severe degradation and wear damage were observed on the pump shaft, seal, and outboard bearing. Substantial abrasive wear was visible on the pump shaft adjacent to the seal on the inboard side of the bearing housing (**Figure 23**). Extensive contact wear was also visible on the seal gland (**Figure 24**).

Prior to disassembly of the Tank 80-8 circulation pump, radial displacement of the pump shaft was observed on the outboard side on the bearing frame, which is typically indicative of extensive bearing failure. Subsequent disassembly of the bearing housing confirmed failure of the outboard thrust bearing.

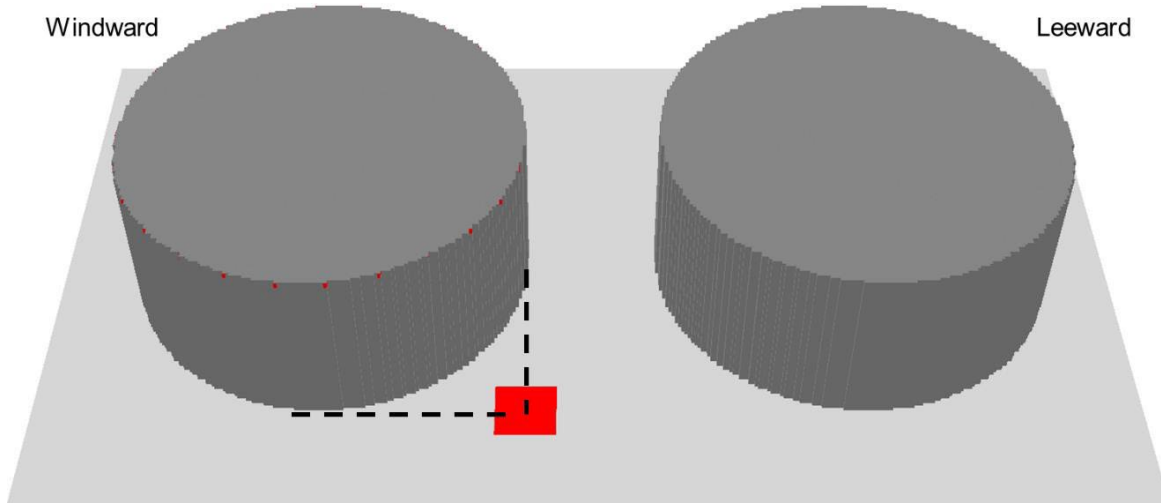
of the thermal exposure. The heating on the adjacent tank was asymmetric, with the side closer to the pool experiencing heat fluxes 2-4x higher than the further side. In addition, the peak location occurred approximately 2.5 m above the ground, rather than 1.0 m below the rim of the tank.

Figure A-33. Location of pool fire.

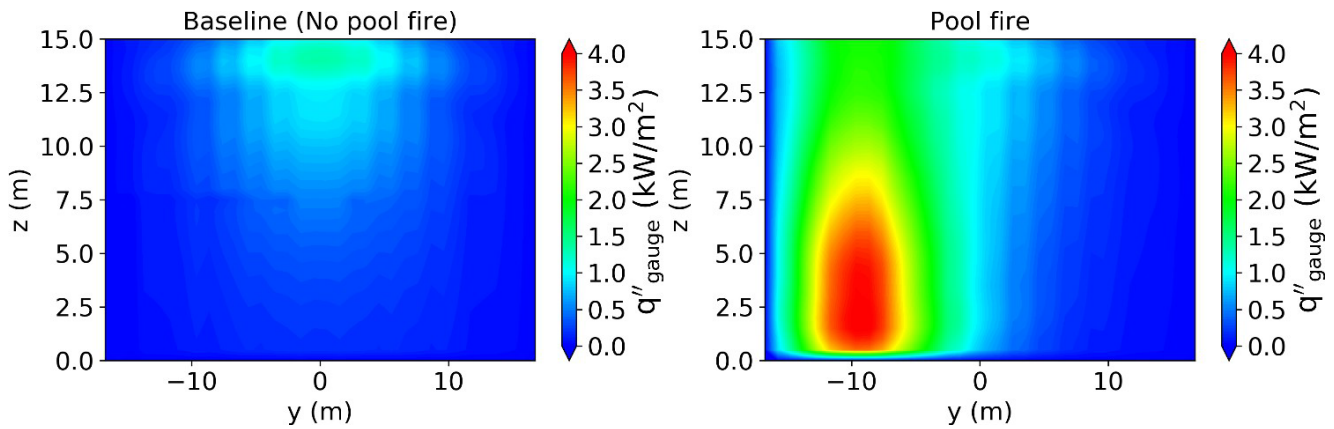
Figure A-35. Comparison of heat flux on adjacent tank with and without the addition of a pool fire.

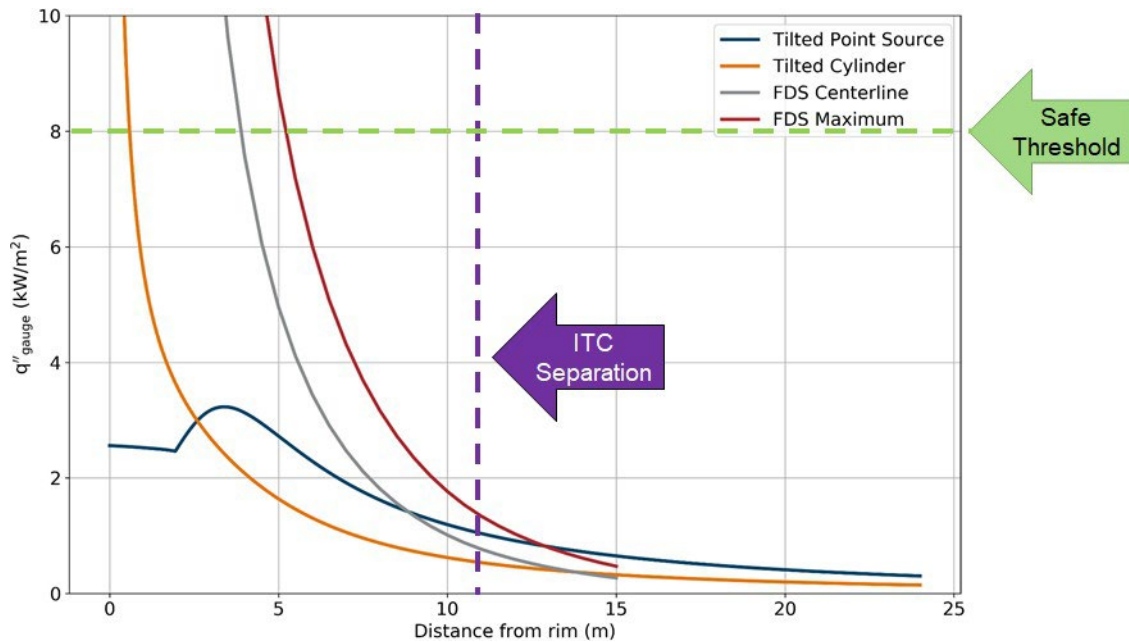
correlation in Eq. 15. Note that the curve corresponding to the FDS maximum was calculated in post-processing by scaling the centerline measurements by the maximum observed off-center on the windward side of the tank. The results indicate that both hand calculation methods underpredict the thermal exposure to the adjacent tank compared with the detailed CFD model.

Figure A-38. Comparison of thermal exposure predictions using each approach.

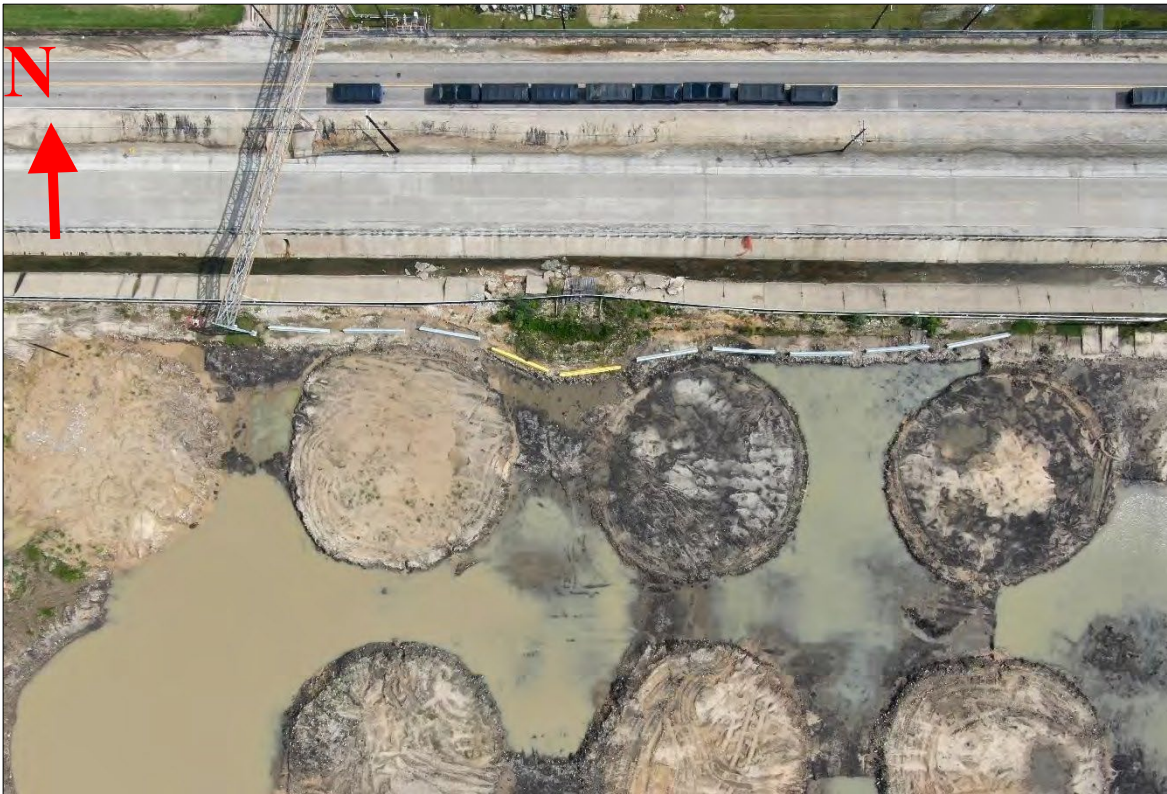
At the time of our site visit, remediation measures had been performed. These included draining the product and water from the site as well as removal of the existing tanks and above-grade piping. The top surface of the soil inside the containment area appeared to have been significantly disturbed by these initial remediation measures. The additional soil brought in to construct the containment remained in place. New T-rail Jersey barriers were in place, likely to prevent equipment involved in the remediation of the tank farm from entering the section of the breach. The elevated pipes that were located just outside the tank farm wall had additional temporary supports added where the original supports were disturbed in the breach. Erosion ditches at the area of the breach had been backfilled. Some sections of the damaged concrete slab that had lined the drainage ditch between the tank farm containment wall and Tidal Road had been removed, as well as sections of the damaged portion of the containment wall. The immediate area of the breach was thoroughly disturbed from the remediation and stabilization operations. However, sections adjacent to the breach along the containment wall appeared to remain minimally disturbed since the incident (Photo 10).

Photo 10: Aerial view of site during July 7, 2021 site visit

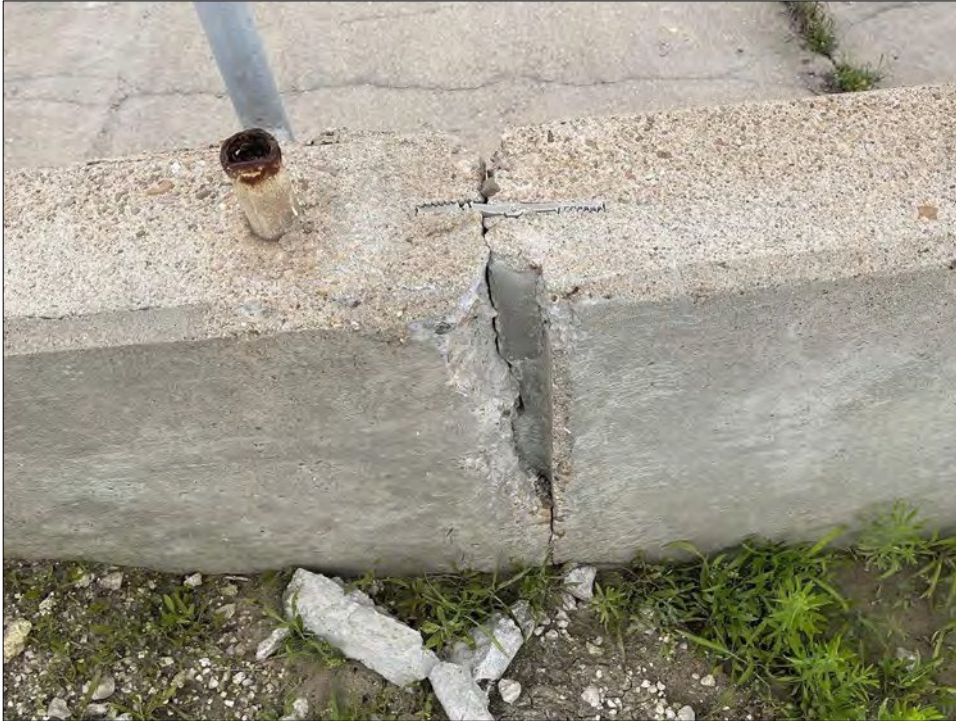
Photo 13: Construction joint with cast-in concrete shear key and centerbulb waterstop

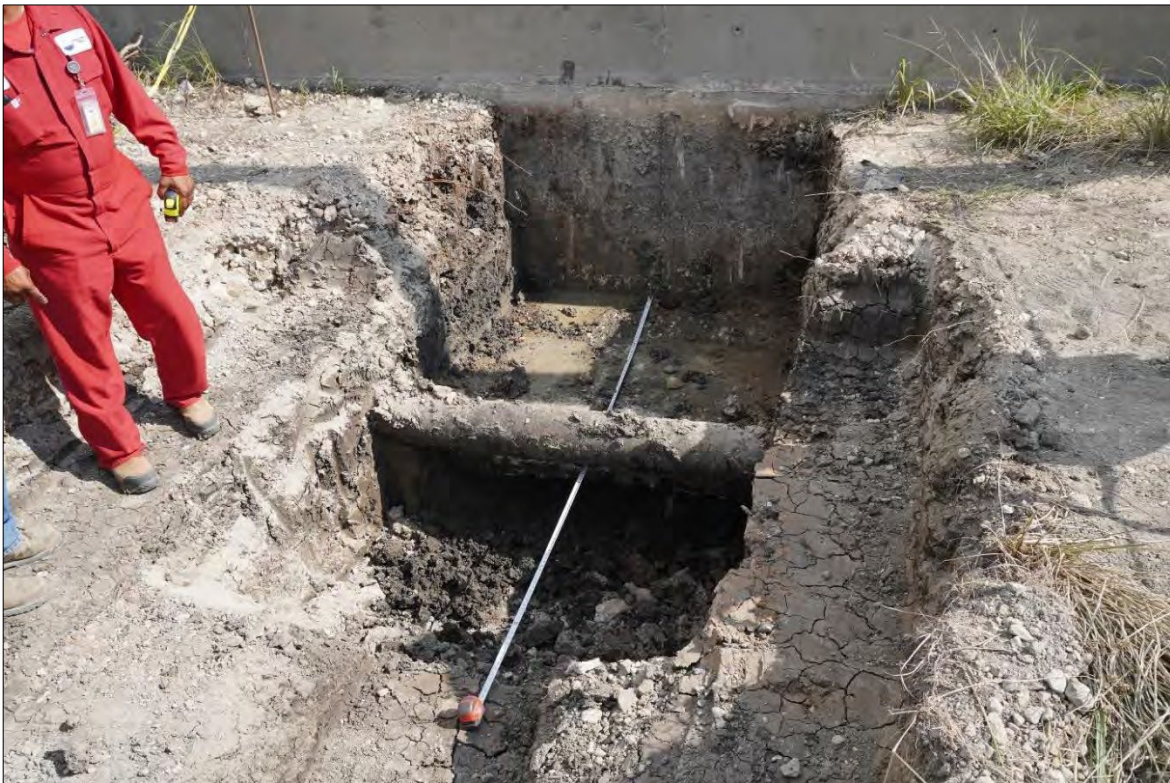
ITC excavated a section of the interior face of the containment wall on June 9, 2022. Atlas Engineering was unable to visit the site during the excavation, however CSB personnel were able to observe the condition of the wall after the excavation and take measurements (Photos 22 & 23). Measurements taken in the excavation area were used to refine the cross-section sketch through the containment wall shown above in Figure 3. The excavation revealed the containment wall extends down 4 feet below the grade level of the interior of the tank farm. There was a horizontal slab extending approximately 5 feet south from the interior face of the containment wall. This slab had a highly irregular edge and bottom surface, indicating it was cast against grade. No standing water was seen in the footing, indicating the natural groundwater level was below the base of the footing. The excavation also revealed the location of an underground firefighting water distribution pipe that supplied the fixed firefighting monitors located along the north wall inside the tank farm.

Photo 22: Containment wall footing excavation, south face of north wall, inside containment area

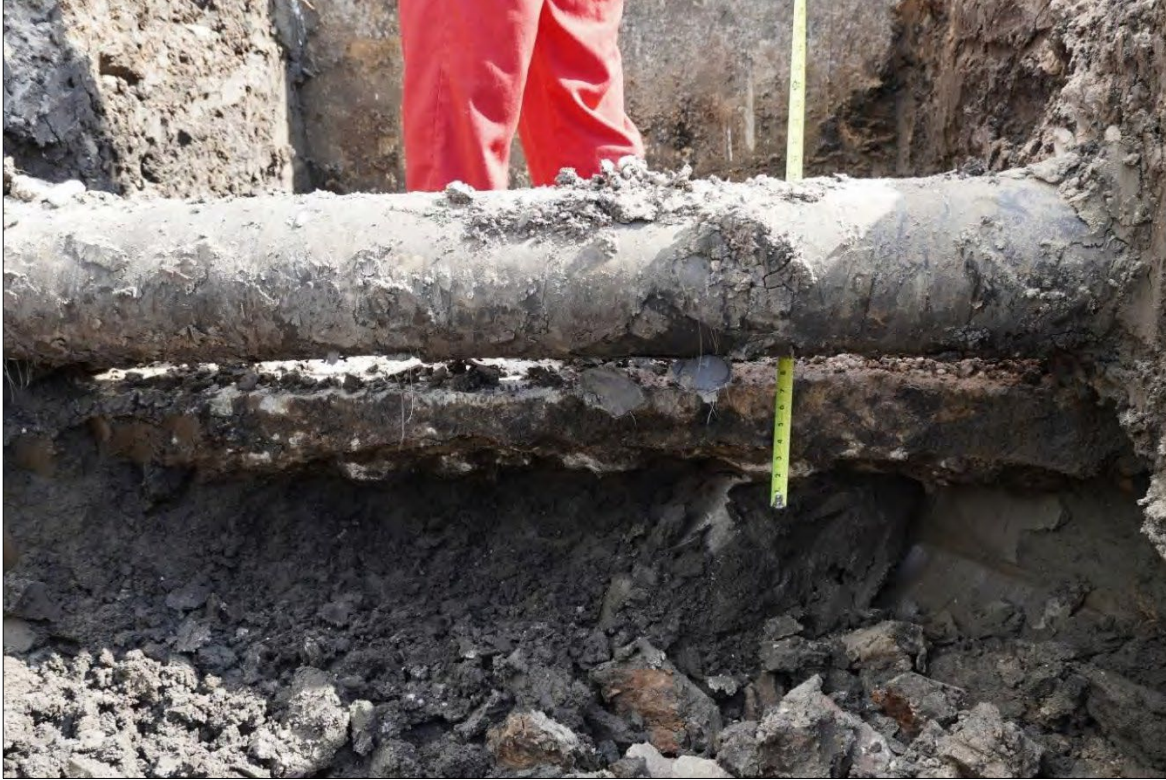
Photo 23: Containment wall footing and underside of footing
